City of Nedlands

Technical Services Reports

TS15.20	Allen Park Cottage
Committee	8 September 2020
Council	22 September 2020
Applicant	City of Nedlands
Employee Disclosure under section 5.70 Local Government Act 1995	Nil.
Director	Jim Duff – Director Technical Services
Attachments	1. Hodge Collard Preston Architectural Report dated 30 June 2019 2. Bushfire Management Report dated 24 January 2020

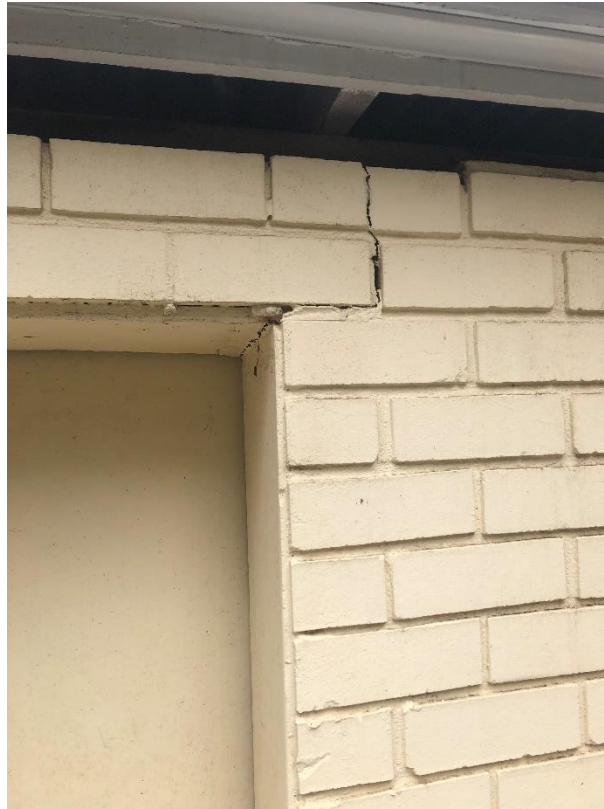
Photograph 3 – Masonry Wall-Cracking Above Door Opening

- Crack stitching to be carried out on masonry walls showing cracking due to ground settlement
- Stormwater
 - Soakwells should be installed on the property to provide a means for stormwater discharge without damaging the cottage's foundations, downpipes from the cottage should discharge into these new soakwells.

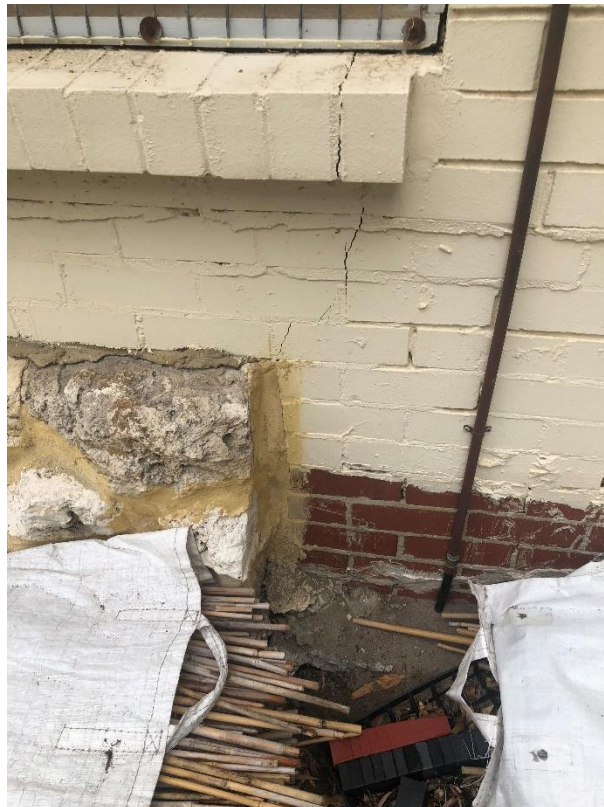
Photograph 4 – Masonry Wall-Cracking Below Window Opening

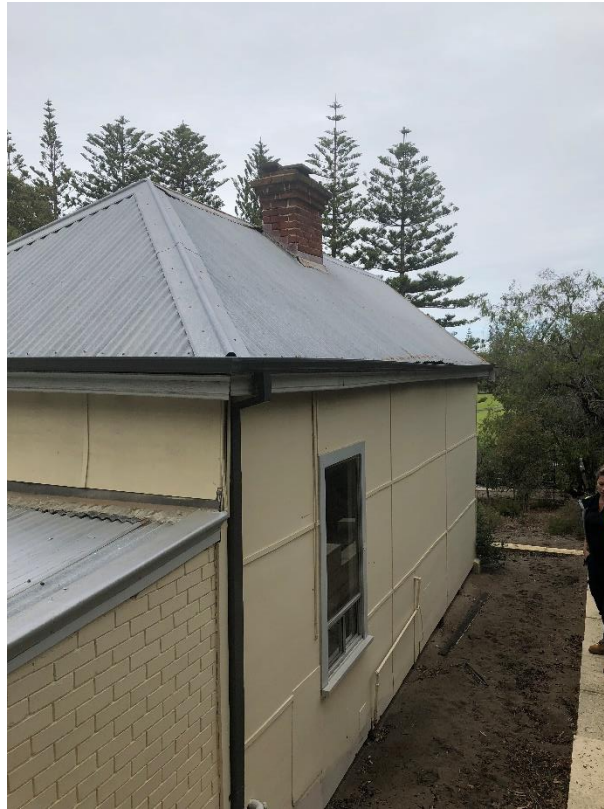
Photograph 5 – West Side of Building-Roof Sheetting Not Fixed Down

- Roof cladding, gutters, downpipes and battens to be replaced with Colorbond roof, including flashings and anticon insulation
- Remove all on-site asbestos, refer to appendices **Asbestos Register** compiled by Environmental site services.

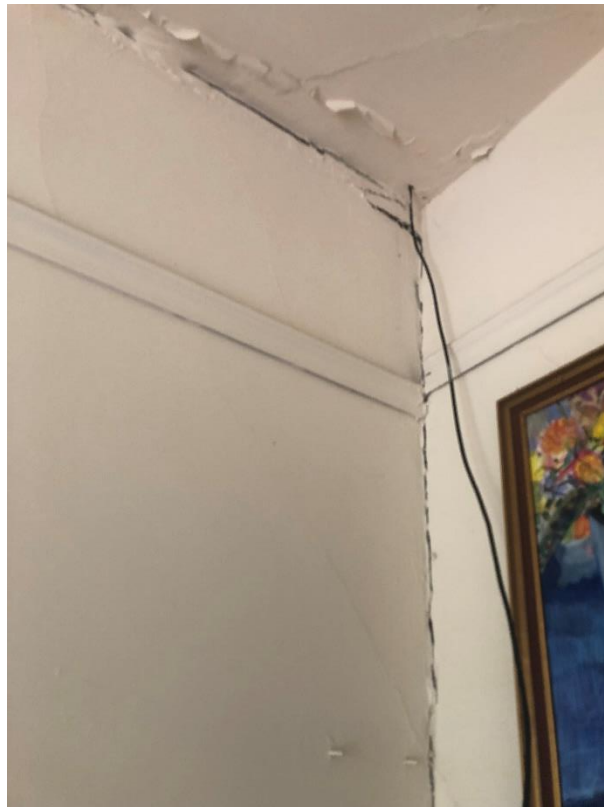
Photograph6 – Cracked Plaster Wall-Lounge Room

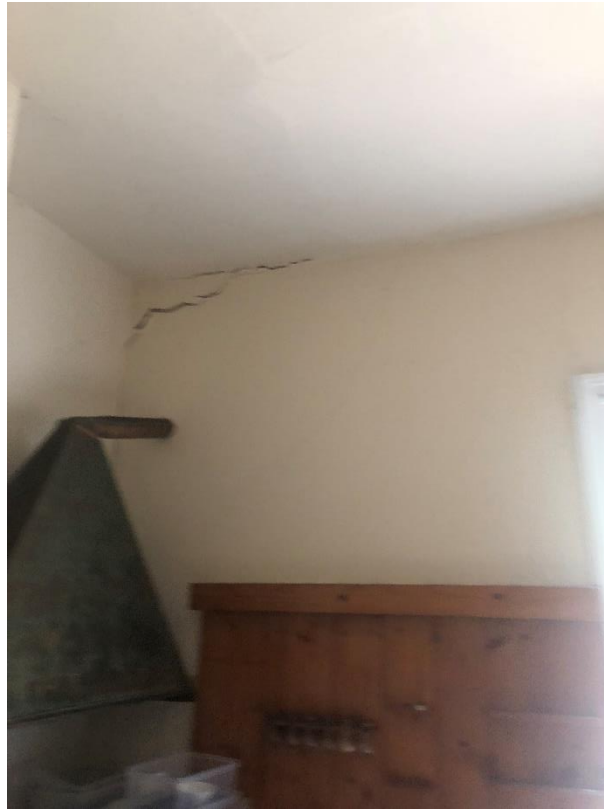
Photograph 7 – Cracked Plaster Wall-Kitchen

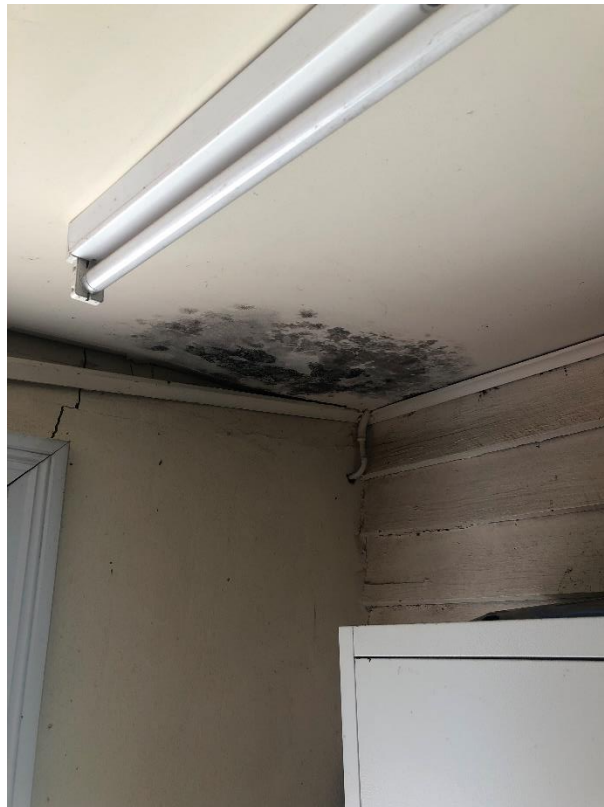
Photograph 8 – Water Damage to Ceiling

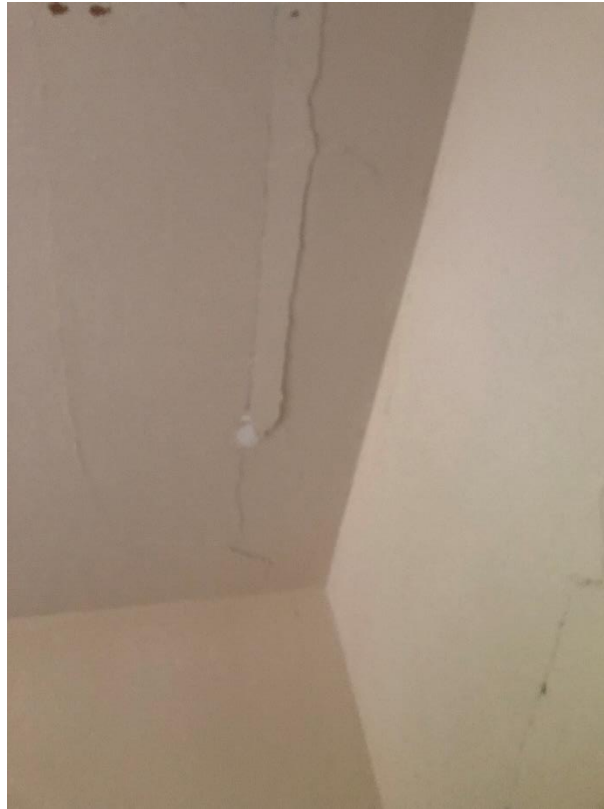
Photograph 9 – Cracked plaster Ceiling – Dining Room

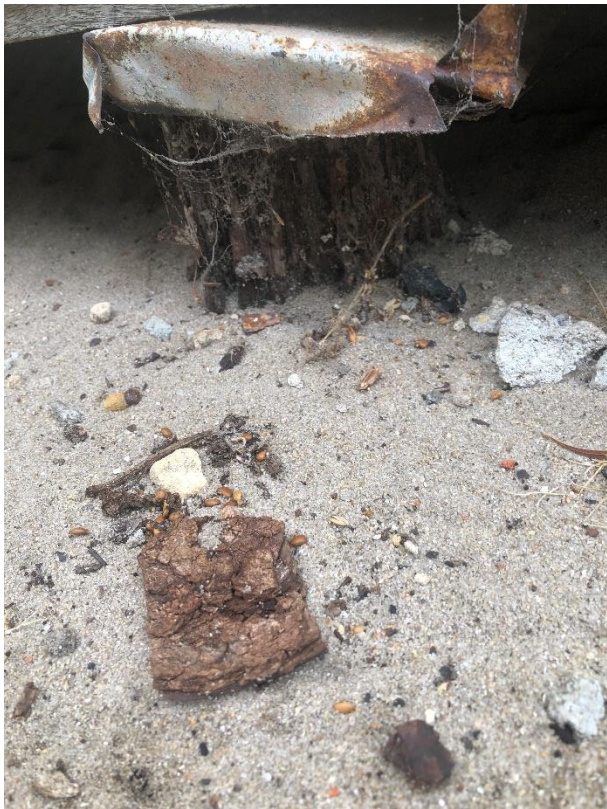
- Main findings risks:
 - Perimeter timber stumps supporting the floor and walls are heavily deteriorated due to termite damage /weathering, causing floors to slope toward external walls. Cracking was also present in external walls due to settlement from the decaying posts.

Photograph 11 – Damaged Timber Stump

- All above ground water and gas supply pipes must be metal
- Structural
 - Re-stump damaged timber posts, a concrete foundation will be required under all posts.

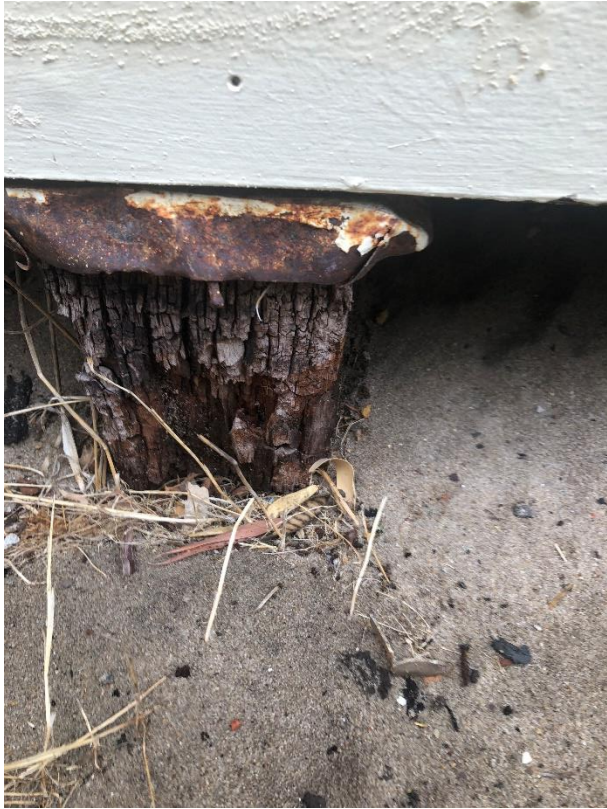
Photograph 12 – Damaged Timber Stump

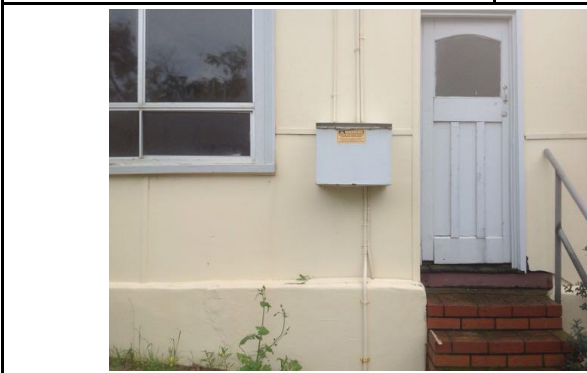
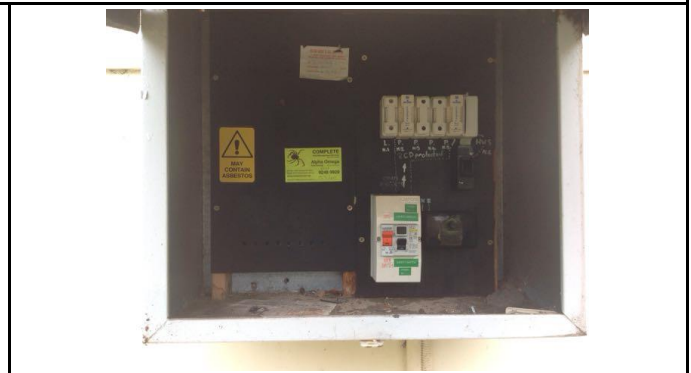
20723		Location		Description		Risk	
Internal/ External:	External		Material Description:	Cement Product	Condition:	Poor (Damaged)	
Level:	External Ground		Sample No.:	Assumed same as ESS 004626	Friability:	Non Friable	
Building:	Friends of Allen Park Cottage		Sample Status:	Asbestos Detected	Disturbance Potential:	Low	
Extent (approx.):	25 m ²	Current Label:	Labelled	Sample Ref:	BA3259/07	Risk Rating:	Low
Room/Area:	001 - Southern Elevation - Wall & Gable Cladding				Action Rating:	A3

NOHSC 2018 (2005) Appendix E: Sealing, Painting, Coating and Cleaning of Asbestos Cement Products;
NOHSC 2018 (2005) Appendix C: Selection and Use of Personal Protective Equipment (PPE)

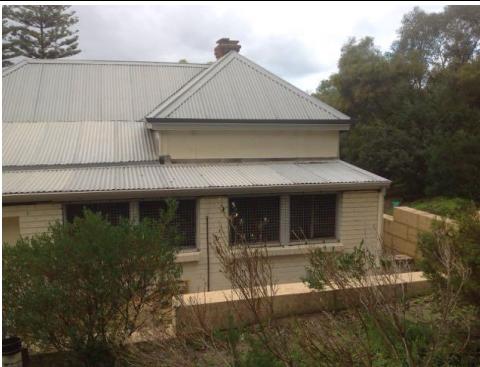
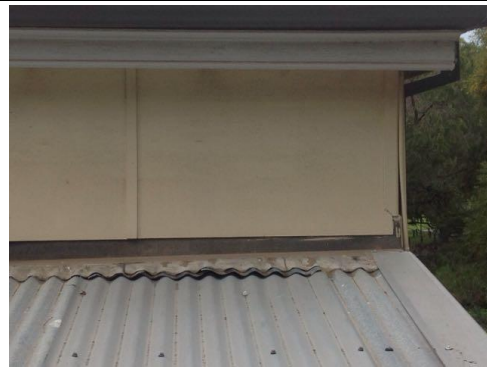
20729		Location		Description		Risk	
Internal/ External:	External		Material Description:	Cement Product	Condition:	Very Poor (High Amount of Damage)	
Level:	External Ground		Sample No.:	Assumed same as ESS 004626	Friability:	Non Friable	
Building:	Friends of Allen Park Cottage		Sample Status:	Asbestos Detected	Disturbance Potential:	Moderate	
Extent (approx.):	>3 no	Current Label:	Unlabelled	Sample Ref:	-	Risk Rating:	Low
Room/Area:	004 - Eastern Elevation - Debris				Action Rating:	A2

NOHSC 2018 (2005) Appendix E: Sealing, Painting, Coating and Cleaning of Asbestos Cement Products;
NOHSC 2018 (2005) Appendix C: Selection and Use of Personal Protective Equipment (PPE)
