Technical Services Reports

Committee Consideration – 11 September 2012

TS18.12	Request for Retrospective Approval of Nature Strip Development at 47 Esplanade, Nedlands
----------------	---

TS19.12	Requests for Street Tree Removals Referred for Council Consideration
----------------	---

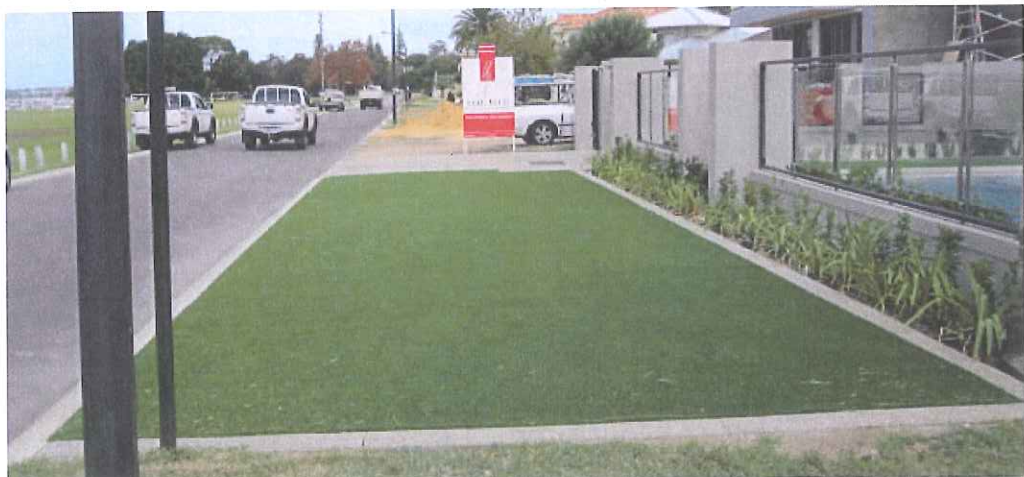
The nature strip development currently comprises the approximate percentages of surface types (refer - Figure 1):

- 28% hardstand (crossover);
- 16% garden bed; and
- 56% artificial grass.

- the nature strip area is near to level;
- the sub base consists of 'cracker dust', or similar product, that has been compacted and would not provide a suitably permeable layer for drainage purposes; and
- an evaluation of the nature strip area drainage characteristics has determined that during a significant rainfall event, there is the potential for storm water to be discharged into the road drainage system.

Figure 1 - Nature strip development at 47 Esplanade, Nedlands

Council approves the request for retrospective approval of the nature strip development adjacent to 47 Esplanade, Nedlands subject to the following conditions being completed within 28 days ensuring compliance with the City of Nedlands Nature Strip Development policy:

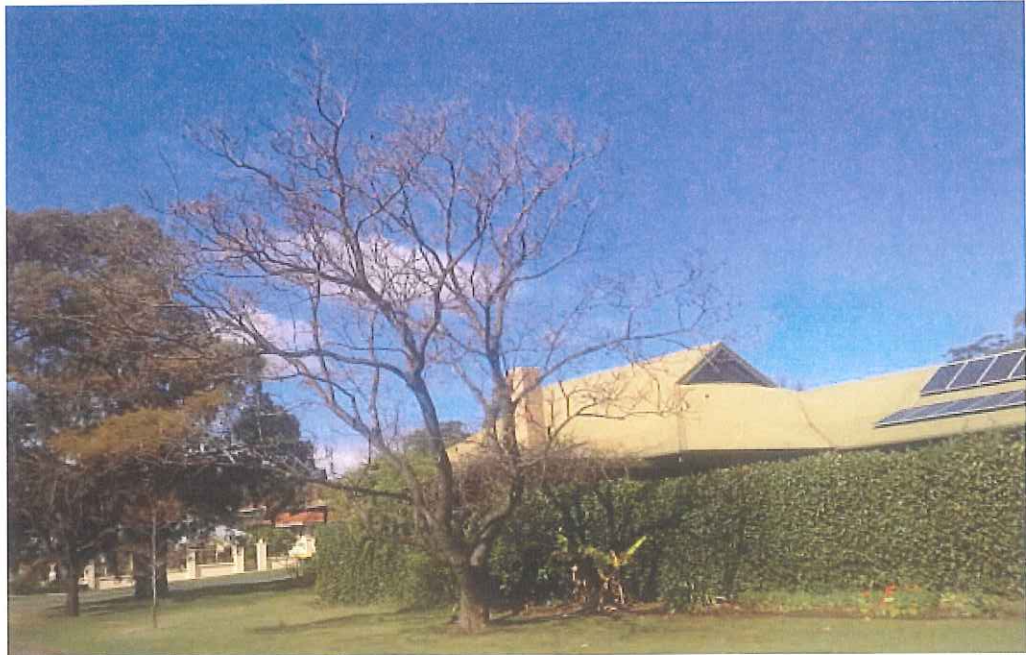
The tree is located on the common alignment within the nature strip (refer to Figure 1). The tree has little to no encroachment upon the boundary of the property (refer to Figure 2). For leaves to enter the pool it would require a moderate breeze from a north-east to north-west direction. This wind direction is not considered a prevailing wind in the Perth region during late autumn and early winter when leaf drop would be most prevalent.

Figure 1 – Location of Jacaranda on Barcoo Avenue nature strip.

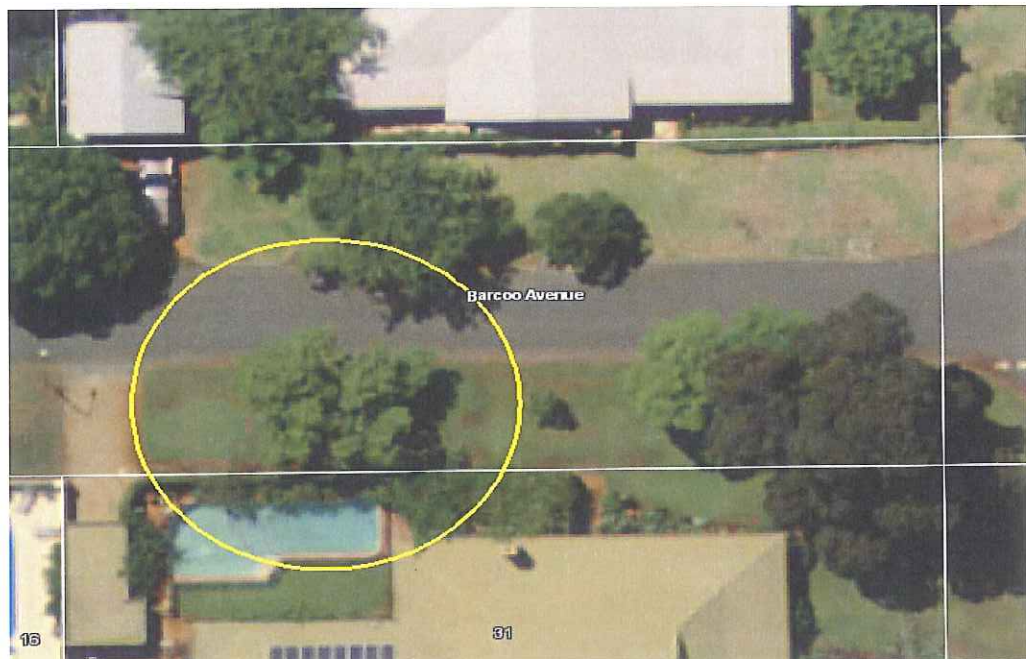
Figure 2 – Aerial photo showing extent of encroachment over property boundary.

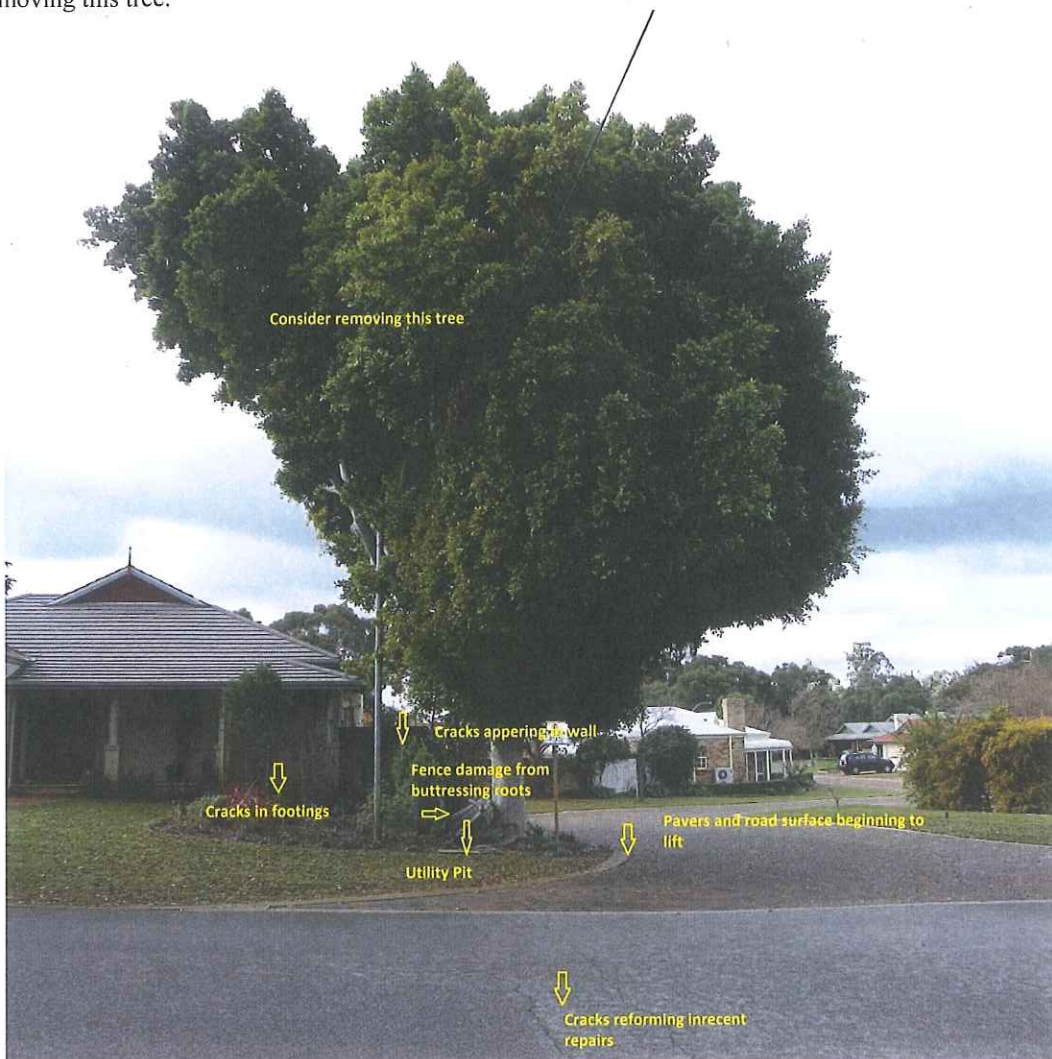
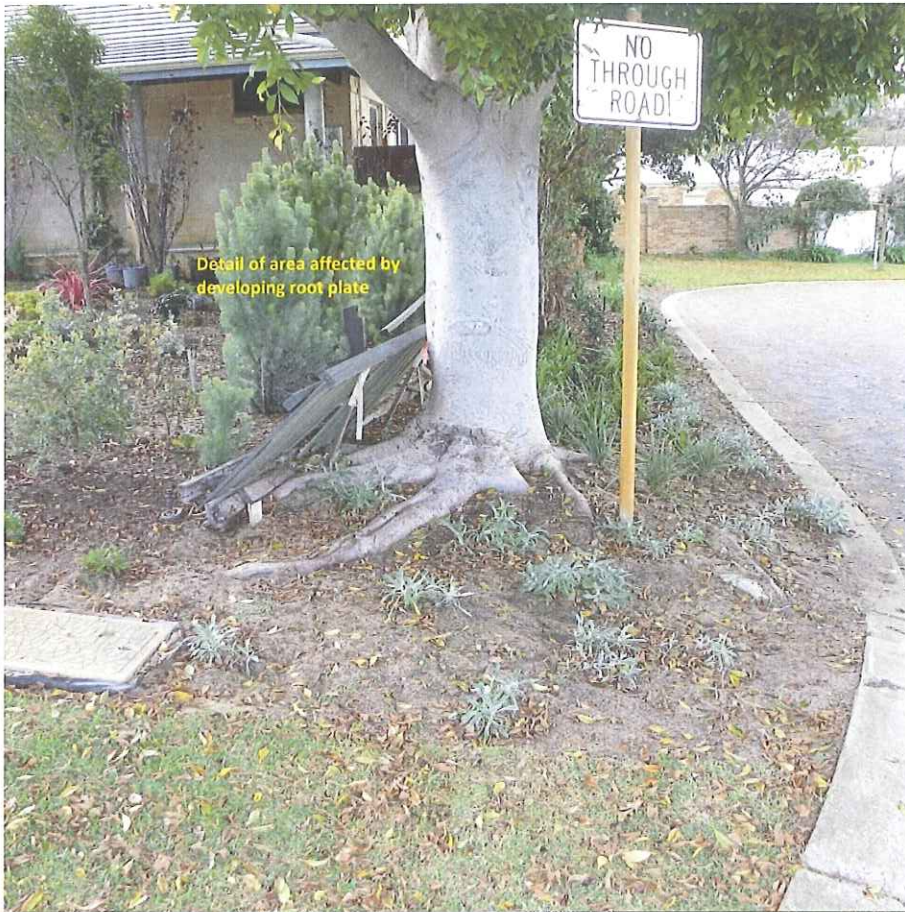
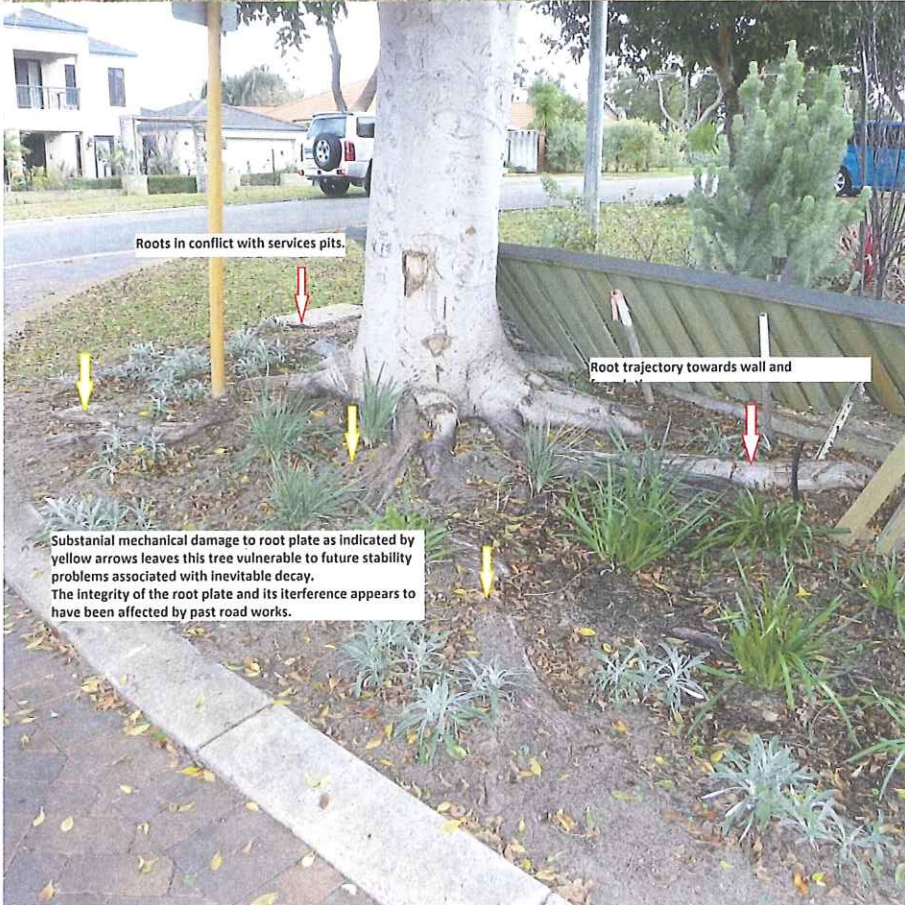
The road reserve area on the southern side of the tree contains the bulk of the basal zone & root plate which has sustained damage by mechanical means on the upper surfaces. Some of the roots have been reduced to contain them within the curb line and also facilitate past construction of an intersecting road.

Recovery of a root plate of sufficient size to maintain the mature dimensions of this tree species is unlikely, due to damage and inevitable decay that can be expected to develop in important and essential components of the root plate structure.

Root plate damage is evident here to the extent that, future stability issues can be anticipated, due to a combination of factors that have occurred as a result of past road and estate development.

Detail of area affected by developing root plate

Roots in conflict with services pits.

Substantial mechanical damage to root plate as indicated by yellow arrows leaves this tree vulnerable to future stability problems associated with inevitable decay. The integrity of the root plate and its interference appears to have been affected by past road works.

Consider removing this tree.

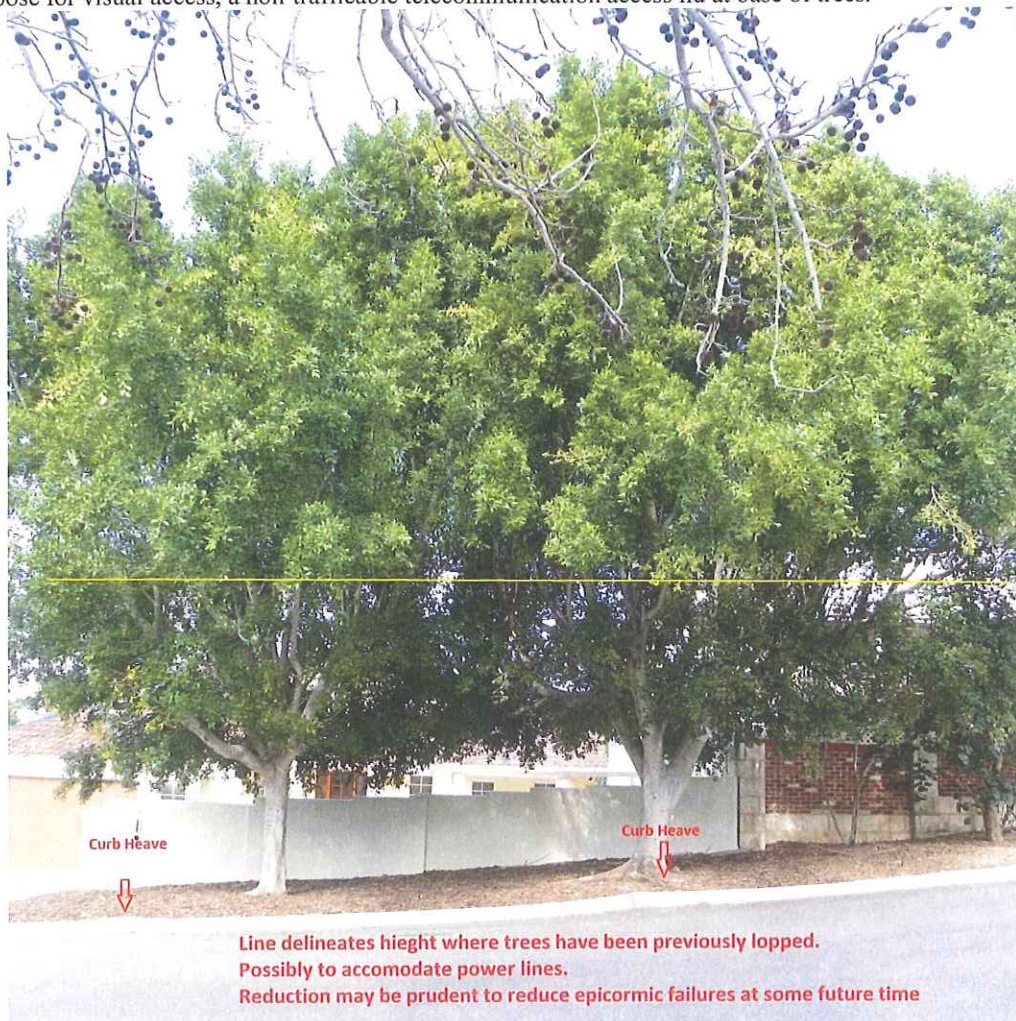
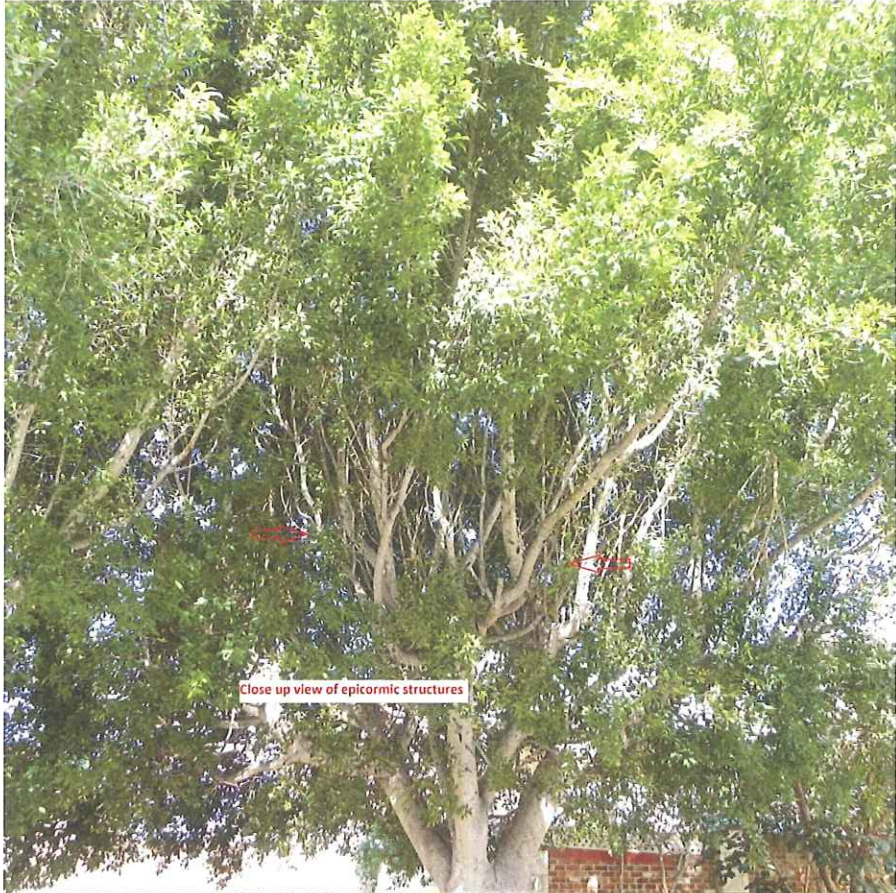
Epicormic growth resulting from trees that have been topped or lopped can and does lead to branch failures associated largely, to a result of competing growth and reduced holding capacity of the remnant branch or stem or coppiced area.

A root barrier dividing the trees and the fence may be a useful addition to reduce future damage from root encroachment. Root encroachment has also begun to lift curbing at the roads edge.

Close up view of epicormic structures

Carry out additional pruning to clear boundary line if this is of concern to ratepayer.

Clear and expose for visual access, a non-trafficable telecommunication access lid at base of trees.

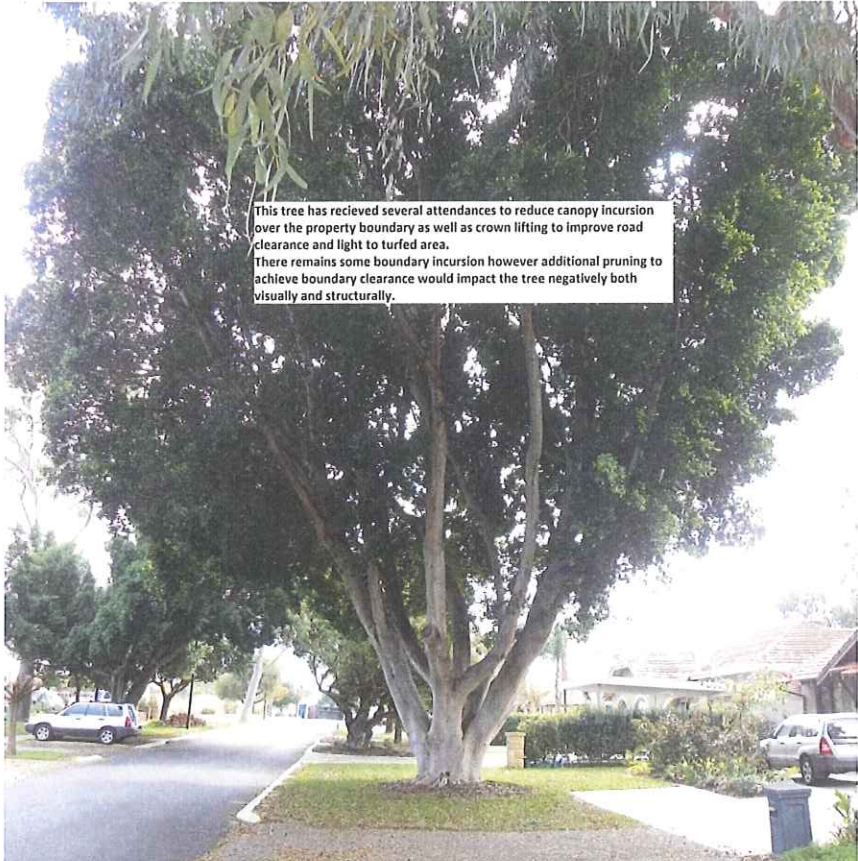
This tree has received several attendances to reduce canopy incursion over the property boundary as well as crown lifting to improve road clearance and light to turf area. There remains some boundary incursion however additional pruning to achieve boundary clearance would impact the tree negatively both visually and structurally.

Continue to monitor the tree annually with some consideration to conservative pruning on the property boundary if requested. Full Boundary clearance should be avoided with this tree if possible.

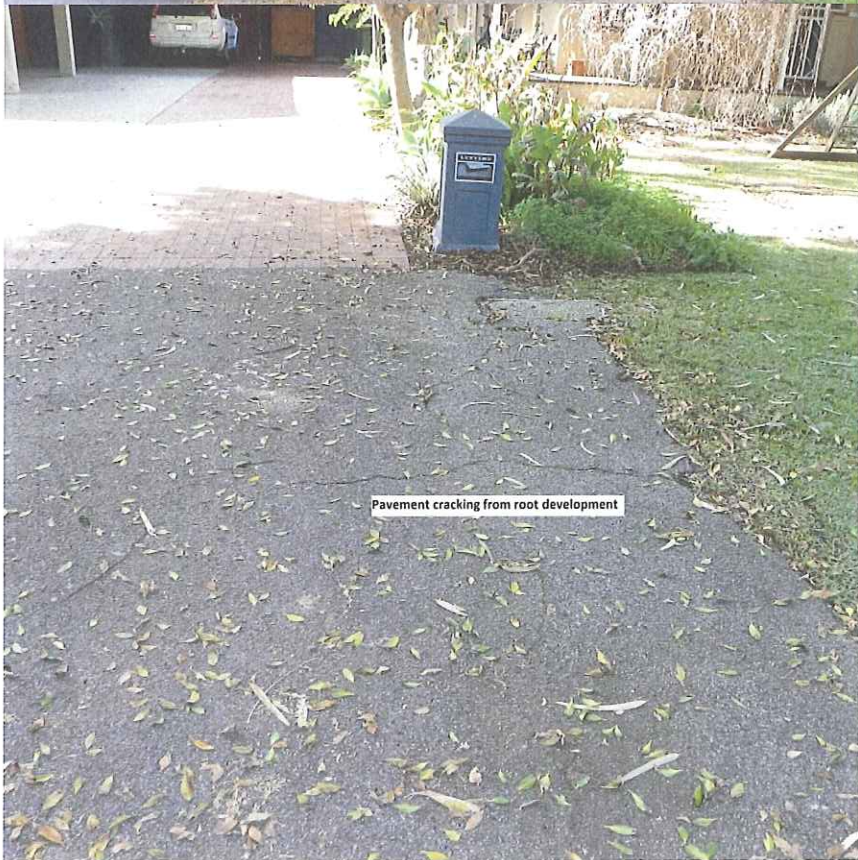
It is here that we can see cracks and some surface delamination and deformity consistent with root incursion over time.

Pavement cracking from root development

Letter box appears to have some heave of perpendicular probably from roots.
