City of Nedlands

Technical Services Reports

TS15.20	Allen Park Cottage
Committee	8 September 2020
Council	22 September 2020
Applicant	City of Nedlands
Employee Disclosure under section 5.70 Local Government Act 1995	Nil.
Director	Jim Duff – Director Technical Services
Attachments	1. Hodge Collard Preston Architectural Report dated 30 June 2019 2. Bushfire Management Report dated 24 January 2020

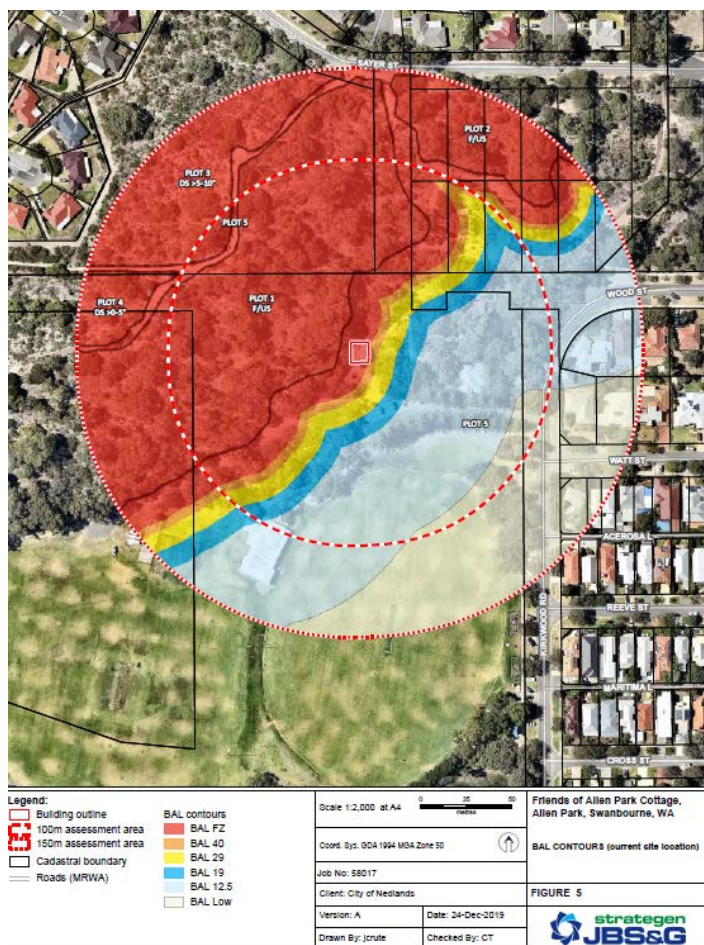
Figure 1: Showing cottage location inside BAL-FZ

The BAL contour map above indicates that the current site is situated within BAL-FZ and is likely subject to significant radiant heat and ember attack. For compliance to be achieved there is potential to reduce the radiant heat impacts on the subject site in its current location.

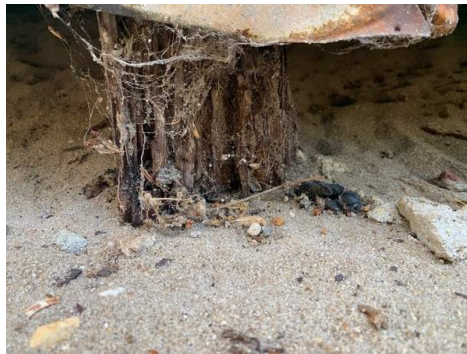
Photo Ref #18

Heavy stump sinkage and damage on the high sided Western side.

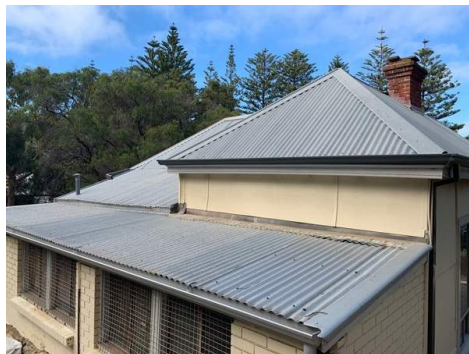
Photo Ref #25

Sheets rusted through in spots here

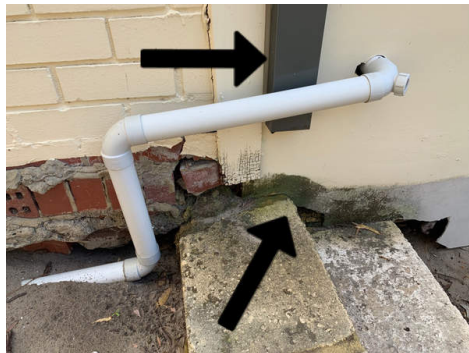
Photo Ref #29

The grey down pipe here is dispersing down the vulnerable side of the building by the kitchen causing ponding, damp and subsidence damage And again on the rear brick store

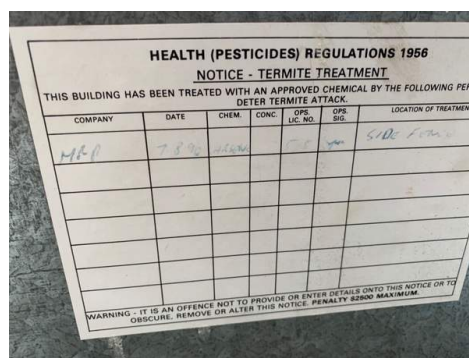
Photo Ref #32

Yes observed

Yes full treatment required however maintenance and renovation works to be discussed first

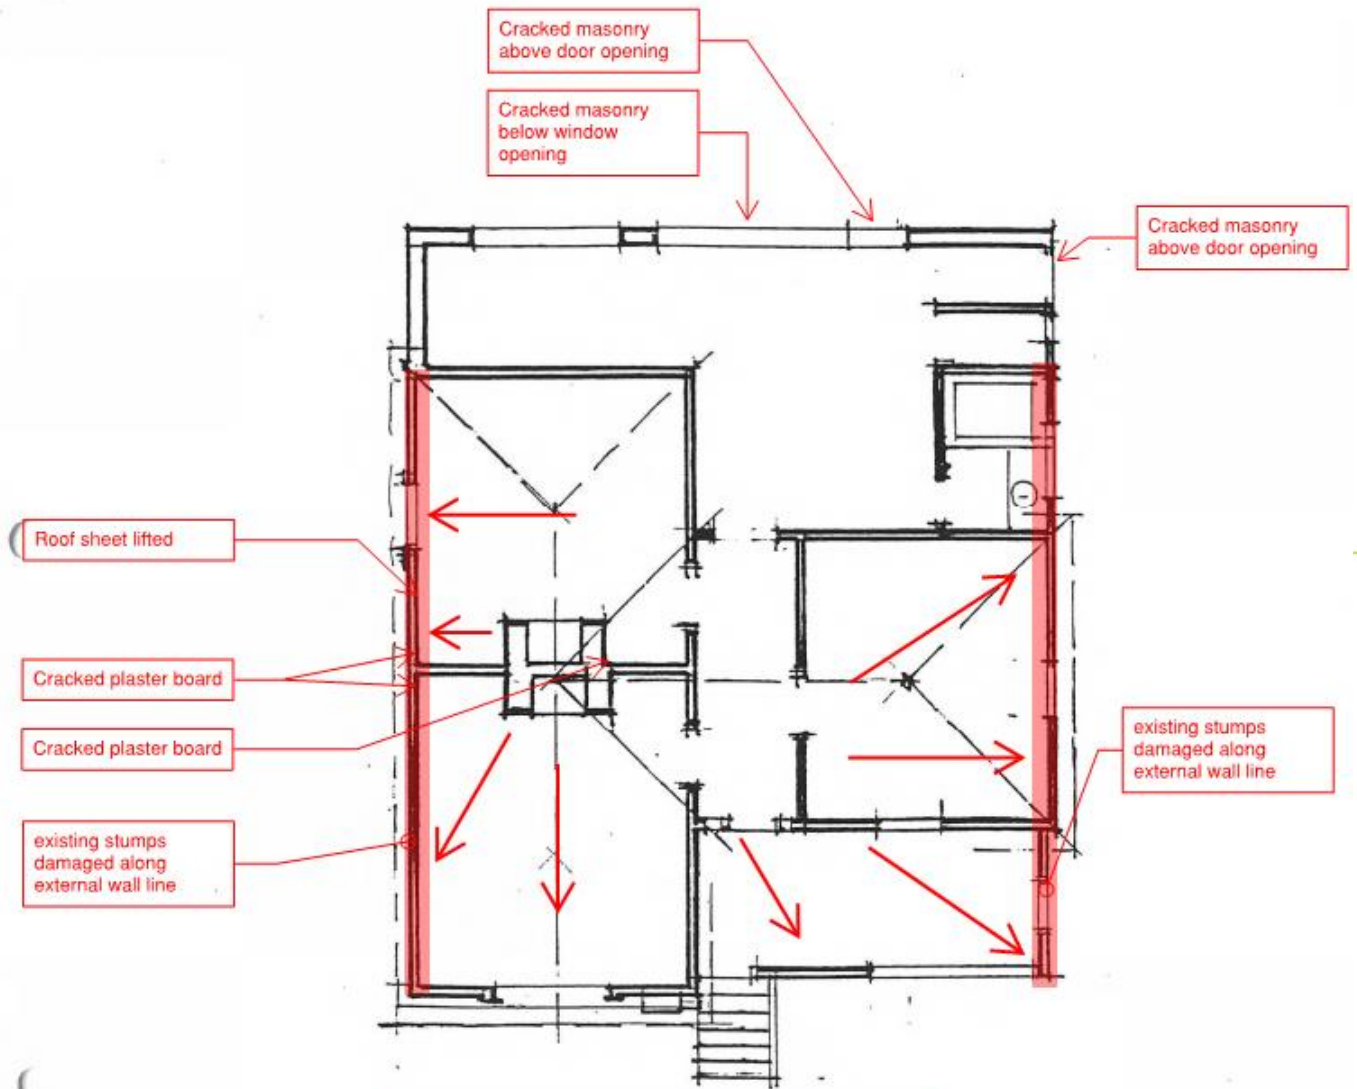
Note:
The arrows marked up typically indicates the slope of the fall as noted during our inspection dated 16/05/2019

Building Defects

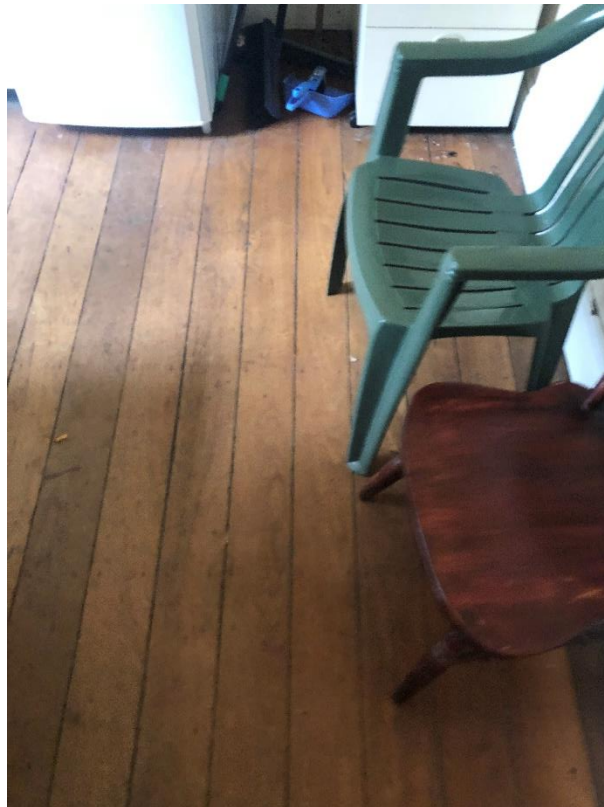
Photograph 10 – Floor Boards

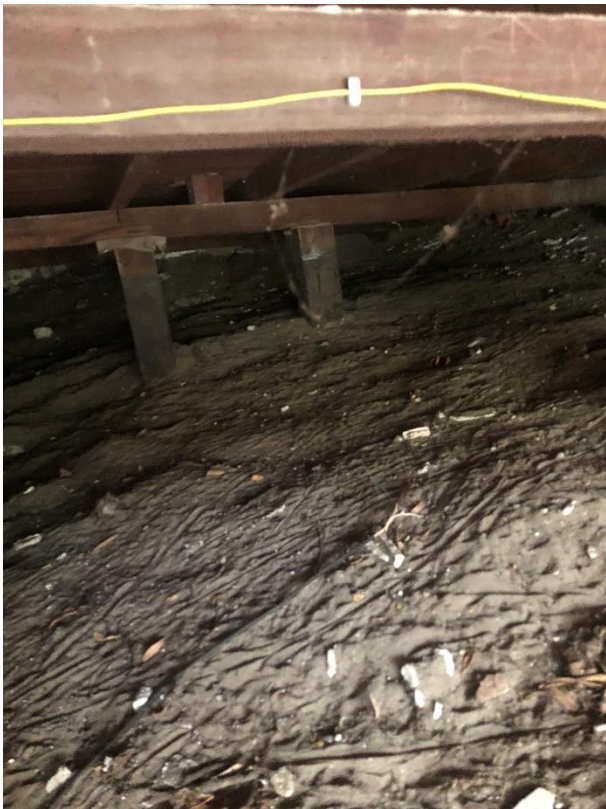
Photograph 13 – Subfloor Structure

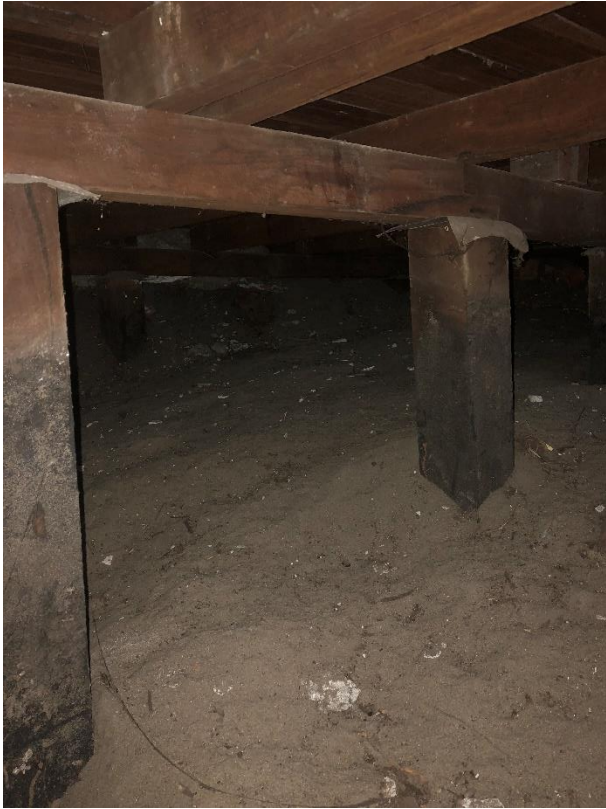
Photograph 14 – Subfloor Structure

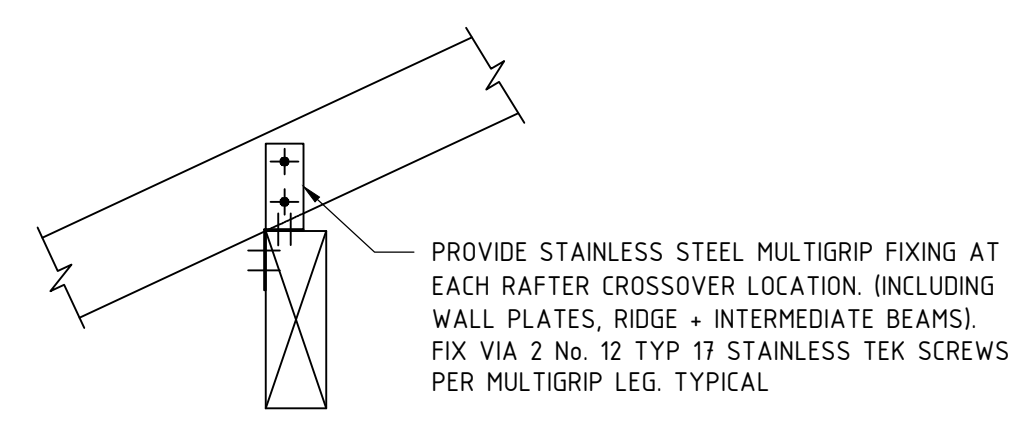
3 DETAIL
SCALE 1:10

NOTE:
THIS DETAIL APPLIES TO ALL RAFTER TO WALL PLATE, RIDGE BEAM/INTERMEDIATE BEAM INTERFACES.

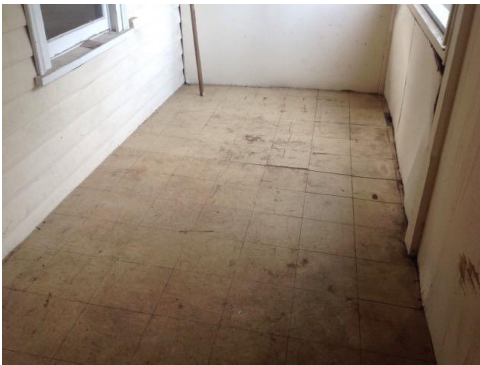
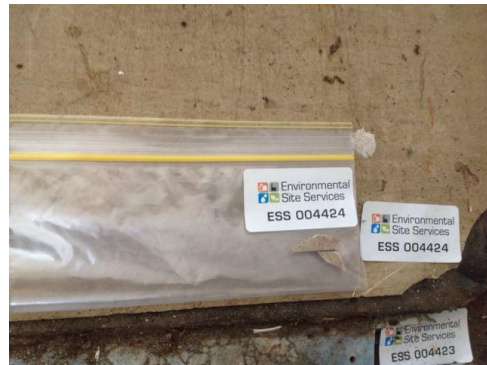
20717	Location			Description		Risk	
Internal/ External:	Internal			Material Description:	Vinyl Tiles	Condition:	-
Level:	Ground Floor			Sample No.:	ESS 004424	Friability:	-
Building:	Friends of Allen Park Cottage			Sample Status:	No Asbestos Detected	Disturbance Potential:	-
Extent (approx.):	10 m ²	Current Label:	Labelled	Sample Ref:	BA3259/02	Risk Rating:	-
Room/Area:	005 - Enclosed Porch - Floor					Action Rating:	-

Nil

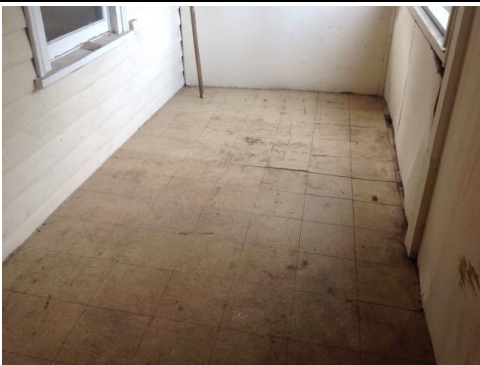
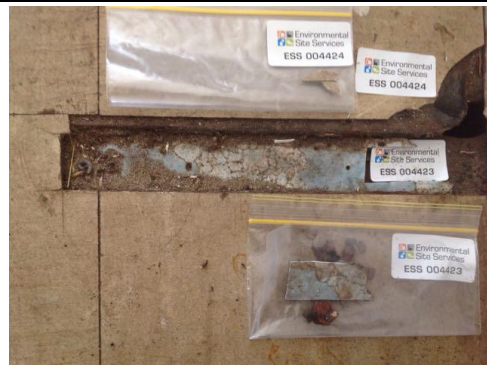
20720	Location			Description		Risk	
Internal/ External:	Internal			Material Description:	Vinyl Tiles	Condition:	-
Level:	Ground Floor			Sample No.:	ESS 004423	Friability:	-
Building:	Friends of Allen Park Cottage			Sample Status:	No Asbestos Detected	Disturbance Potential:	-
Extent (approx.):	10 m ²	Current Label:	Labelled	Sample Ref:	BA3259/01	Risk Rating:	-
Room/Area:	005 - Enclosed Porch - Floor - Second blue vinyl floor covering beneath beige vinyl tiles.					Action Rating:	-

Nil

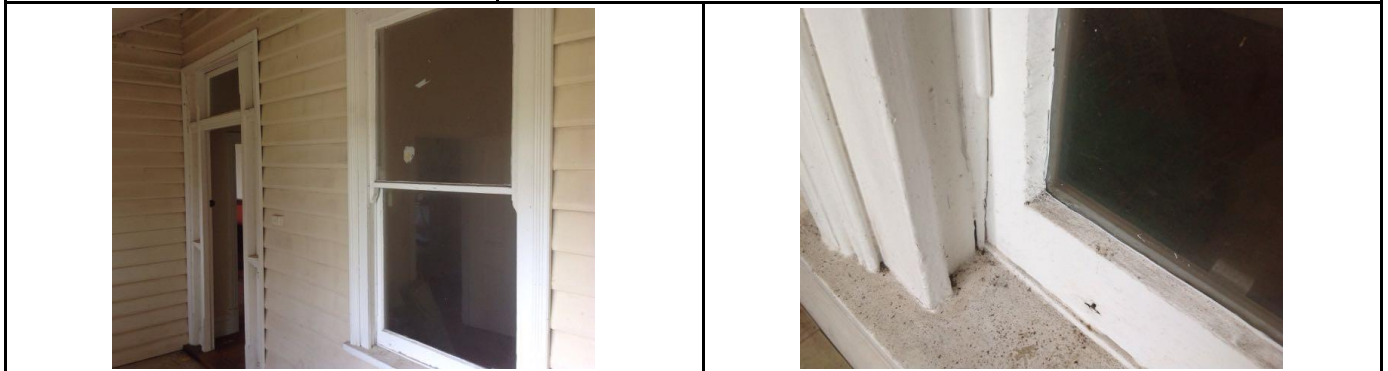
20724		Location		Description		Risk	
Internal/ External:	Internal		Material Description:	Mastic	Condition:	-	
Level:	Ground Floor		Sample No.:	ESS 004627	Friability:	-	
Building:	Friends of Allen Park Cottage		Sample Status:	No Asbestos Detected	Disturbance Potential:	-	
Extent (approx.):	3 no	Current Label:	Unlabelled	Sample Ref:	BA3259/08	Risk Rating:	-
Room/Area:	005 - Enclosed Porch - Window frame putty				Action Rating:	-

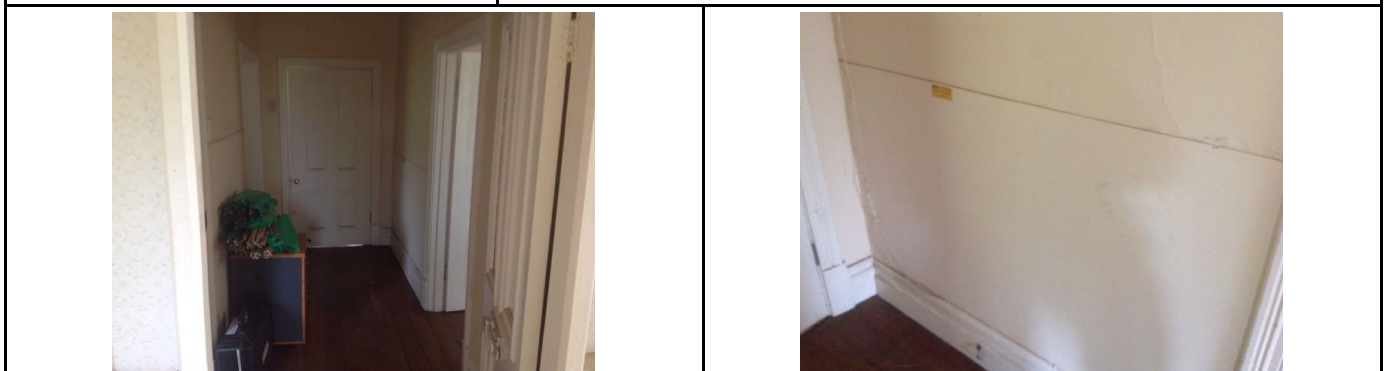
20728		Location		Description		Risk	
Internal/ External:	Internal		Material Description:	Cement Product	Condition:	-	
Level:	Ground Floor		Sample No.:	Assumed same as ESS 004425	Friability:	-	
Building:	Friends of Allen Park Cottage		Sample Status:	No Asbestos Detected	Disturbance Potential:	-	
Extent (approx.):	2 m ²	Current Label:	Labelled	Sample Ref:	BA3259/03	Risk Rating:	-
Room/Area:	006 - Hall - Infill panel				Action Rating:	-

Nil		Remove "May Contain Asbestos" label					
-----	--	-------------------------------------	--	--	--	--	--

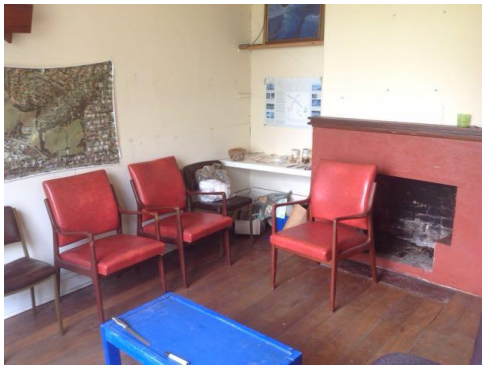
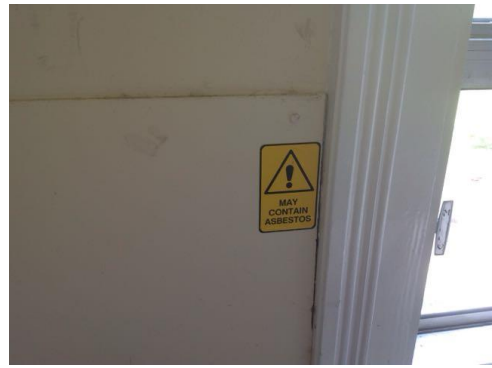
20713		Location		Description		Risk	
Internal/ External:	Internal		Material Description:	Cement Product		Condition:	-
Level:	Ground Floor		Sample No.:	Assumed same as ESS 004425		Friability:	-
Building:	Friends of Allen Park Cottage		Sample Status:	No Asbestos Detected		Disturbance Potential:	-
Extent (approx.):	8 m ²	Current Label:	Labelled	Sample Ref:	BA3259/03	Risk Rating:	-
Room/Area:	007 - Front room - Infill panel				Action Rating:	-

Nil Remove "May Contain Asbestos" label

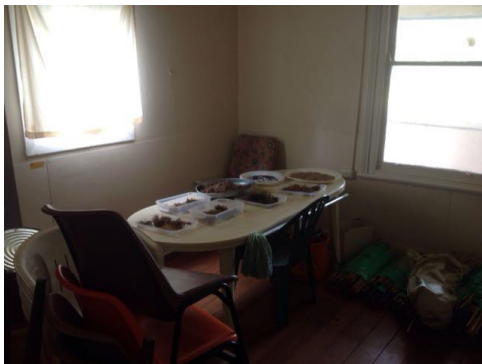
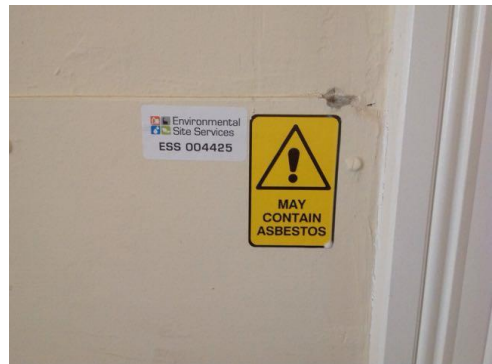
20719		Location		Description		Risk	
Internal/ External:	Internal		Material Description:	Cement Product		Condition:	-
Level:	Ground Floor		Sample No.:	ESS 004425		Friability:	-
Building:	Friends of Allen Park Cottage		Sample Status:	No Asbestos Detected		Disturbance Potential:	-
Extent (approx.):	16 m ²	Current Label:	Labelled	Sample Ref:	BA3259/03	Risk Rating:	-
Room/Area:	008 - Bedroom - Infill panel				Action Rating:	-

Nil Remove "May Contain Asbestos" label

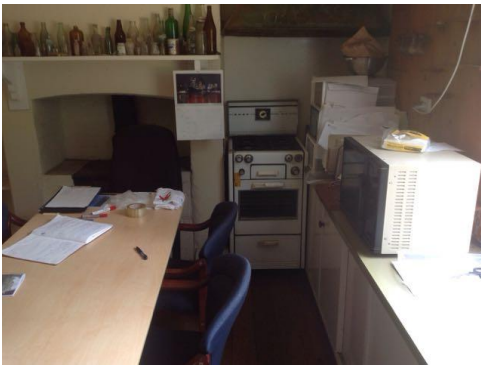
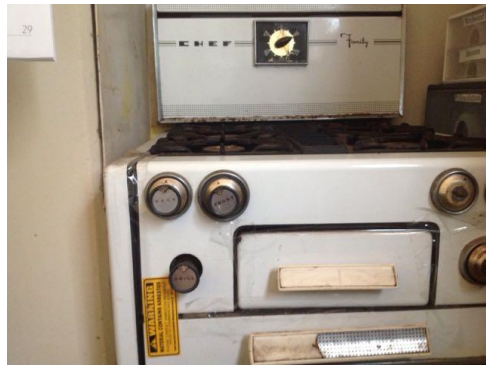
20722		Location		Description		Risk	
Internal/ External:	Internal		Material Description:	Gaskets (rope/woven)	Condition:	Good (Undamaged)	
Level:	Ground Floor		Sample No.:	Not Sampled	Friability:	Non Friable	
Building:	Friends of Allen Park Cottage		Sample Status:	Assumed Asbestos	Disturbance Potential:	Rare	
Extent (approx.):	1 no	Current Label:	Labelled	Sample Ref:	-	Risk Rating:	Low
Room/Area:	009 - Kitchen - Stove				Action Rating:	A3

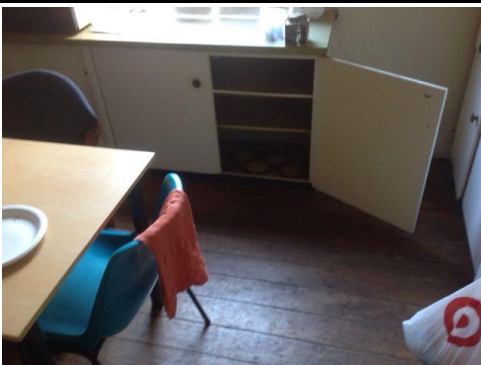
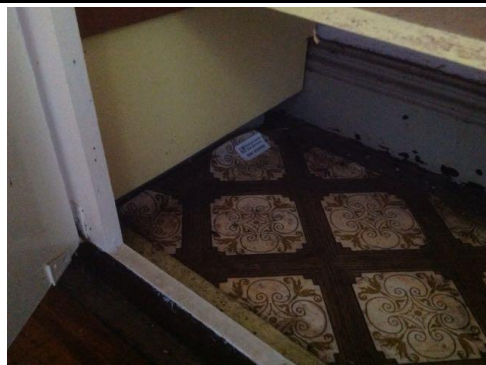
20726		Location		Description		Risk	
Internal/ External:	Internal		Material Description:	Vinyl Tiles	Condition:	-	
Level:	Ground Floor		Sample No.:	ESS 004426	Friability:	-	
Building:	Friends of Allen Park Cottage		Sample Status:	No Asbestos Detected	Disturbance Potential:	-	
Extent (approx.):	1 m ²	Current Label:	Unlabelled	Sample Ref:	BA3259/04	Risk Rating:	-
Room/Area:	009 - Kitchen - Vinyl floor covering - Within cupboard				Action Rating:	-

Nil

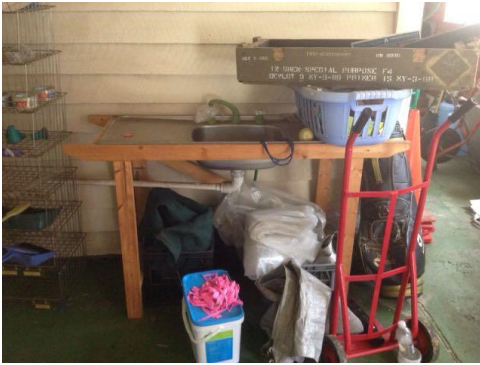
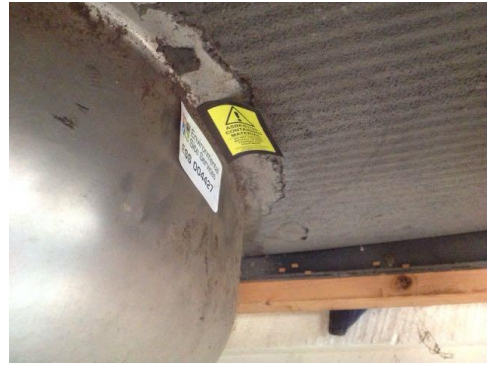
20727		Location		Description		Risk	
Internal/ External:	Internal			Material Description:	Bituminous Product	Condition:	Good (Undamaged)
Level:	Ground Floor			Sample No.:	ESS 004427	Friability:	Non Friable
Building:	Friends of Allen Park Cottage			Sample Status:	Asbestos Detected	Disturbance Potential:	Rare
Extent (approx.):	1 no	Current Label:	Labelled	Sample Ref:	BA3259/05	Risk Rating:	Very Low
Room/Area:	010 - Store Room - Sink					Action Rating:	A4

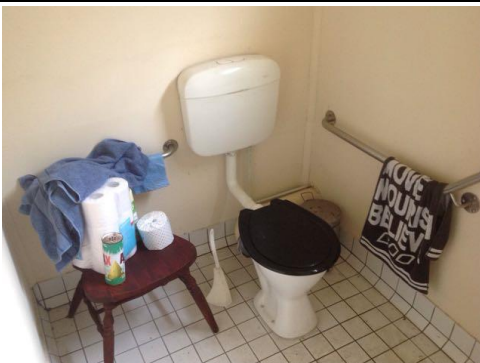
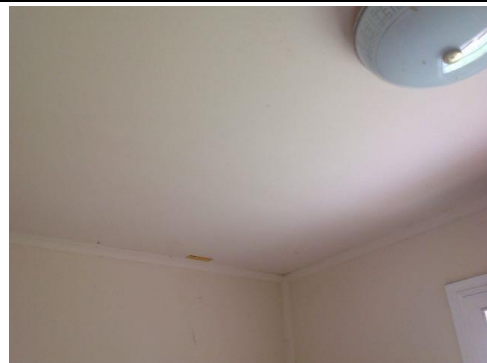
20715		Location		Description		Risk	
Internal/ External:	Internal			Material Description:	Cement Product	Condition:	Good (Undamaged)
Level:	Ground Floor			Sample No.:	Assumed same as ESS 004428	Friability:	Non Friable
Building:	Friends of Allen Park Cottage			Sample Status:	Asbestos Detected	Disturbance Potential:	Low
Extent (approx.):	6 m ²	Current Label:	Labelled	Sample Ref:	BA3259/06	Risk Rating:	Very Low
Room/Area:	011 - WC - Ceiling lining					Action Rating:	A4

NOHSC 2018 (2005) Appendix E: Sealing, Painting, Coating and Cleaning of Asbestos Cement Products;
NOHSC 2018 (2005) Appendix C: Selection and Use of Personal Protective Equipment (PPE)

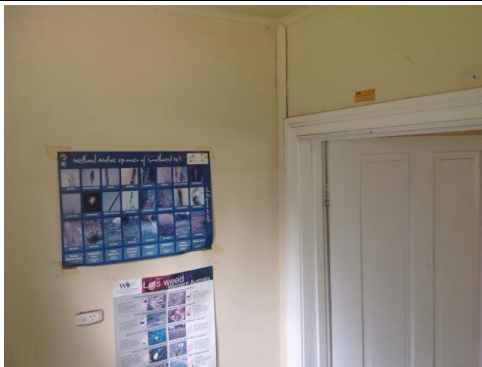
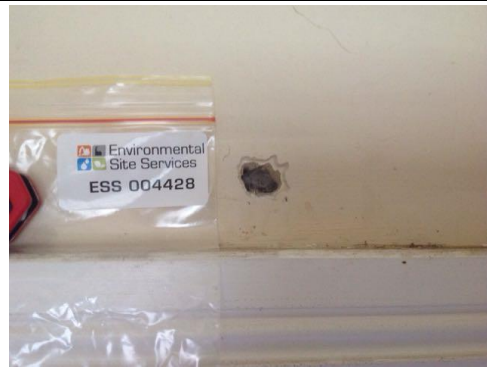
20725		Location		Description		Risk	
Internal/ External:	Internal	Material Description:	Cement Product	Condition:	Good (Undamaged)		
Level:	Ground Floor	Sample No.:	ESS 004428	Friability:	Non Friable		
Building:	Friends of Allen Park Cottage	Sample Status:	Asbestos Detected	Disturbance Potential:	Low		
Extent (approx.):	30 m ²	Current Label:	Labelled	Sample Ref:	BA3259/06	Risk Rating:	Very Low
Room/Area:	011 - WC - Wall Cladding				Action Rating:	A4

NOHSC 2018 (2005) Appendix E: Sealing, Painting, Coating and Cleaning of Asbestos Cement Products;
NOHSC 2018 (2005) Appendix C: Selection and Use of Personal Protective Equipment (PPE)

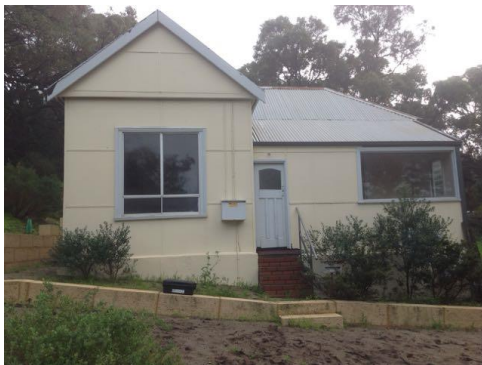
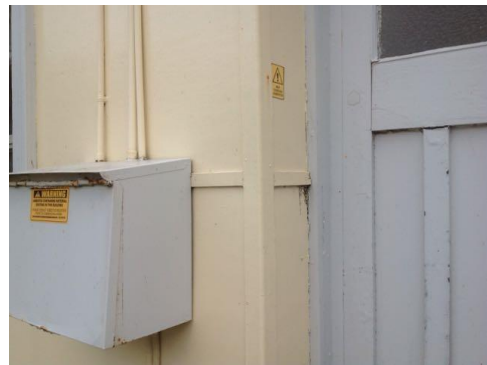
20716		Location		Description		Risk	
Internal/ External:	External		Material Description:	Electrical Mounting Board	Condition:	Good (Undamaged)	
Level:	External Ground		Sample No.:	Not Sampled	Friability:	Non Friable	
Building:	Friends of Allen Park Cottage		Sample Status:	Assumed Asbestos	Disturbance Potential:	Low	
Extent (approx.):	1 no	Current Label:	Labelled	Sample Ref:	-	Risk Rating:	Low
Room/Area:	001 - Southern Elevation - Electrical Mounting Board				Action Rating:	A3

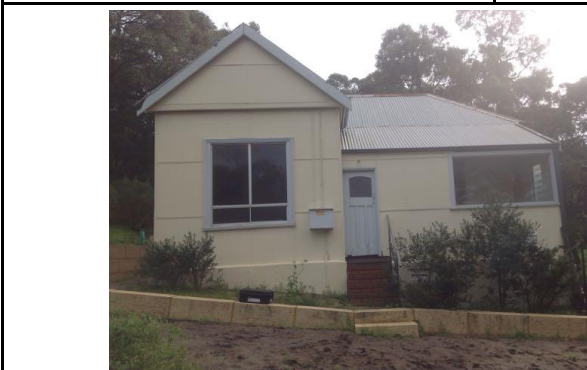
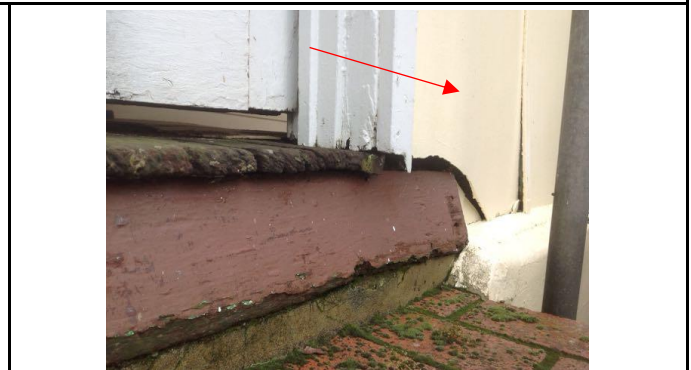
20723		Location		Description		Risk	
Internal/ External:	External		Material Description:	Cement Product	Condition:	Poor (Damaged)	
Level:	External Ground		Sample No.:	Assumed same as ESS 004626	Friability:	Non Friable	
Building:	Friends of Allen Park Cottage		Sample Status:	Asbestos Detected	Disturbance Potential:	Low	
Extent (approx.):	25 m ²	Current Label:	Labelled	Sample Ref:	BA3259/07	Risk Rating:	Low
Room/Area:	001 - Southern Elevation - Wall & Gable Cladding				Action Rating:	A3

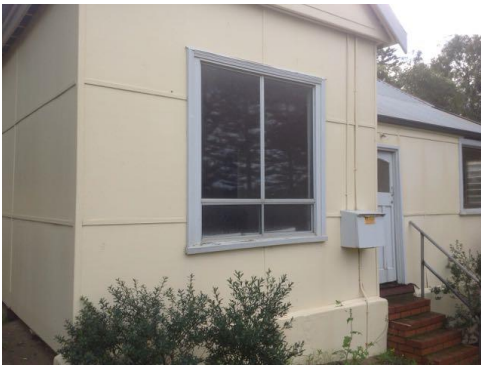
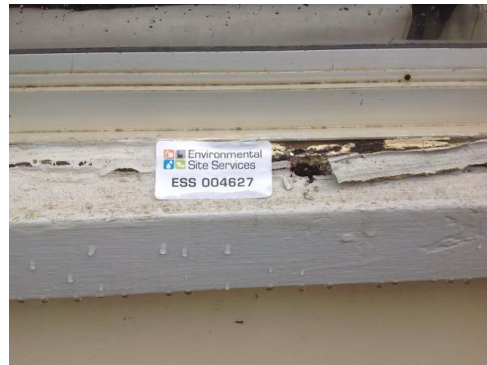
20731		Location		Description		Risk	
Internal/ External:	External		Material Description:	Mastic	Condition:	-	
Level:	External Ground		Sample No.:	ESS 004627	Friability:	-	
Building:	Friends of Allen Park Cottage		Sample Status:	No Asbestos Detected	Disturbance Potential:	-	
Extent (approx.):	2 lin m	Current Label:	Unlabelled	Sample Ref:	BA3259/08	Risk Rating:	-
Room/Area:	001 - Southern Elevation - Window frame putty				Action Rating:	-

Nil

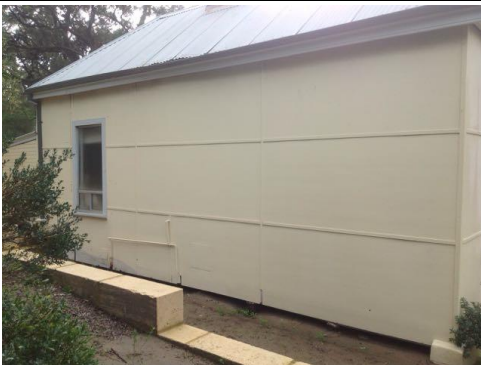
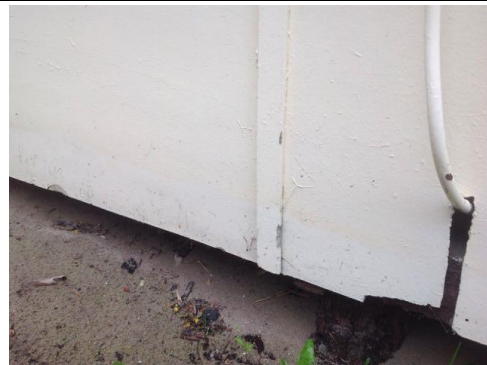
20730		Location		Description		Risk	
Internal/ External:	External		Material Description:	Cement Product	Condition:	Fair (Minor Damage)	
Level:	External Ground		Sample No.:	Not Sampled	Friability:	Non Friable	
Building:	Friends of Allen Park Cottage		Sample Status:	Assumed Asbestos	Disturbance Potential:	Low	
Extent (approx.):	50 lin m	Current Label:	Unlabelled	Sample Ref:	-	Risk Rating:	Low
Room/Area:	002 - Western Elevation - Joint strips to walls				Action Rating:	A3

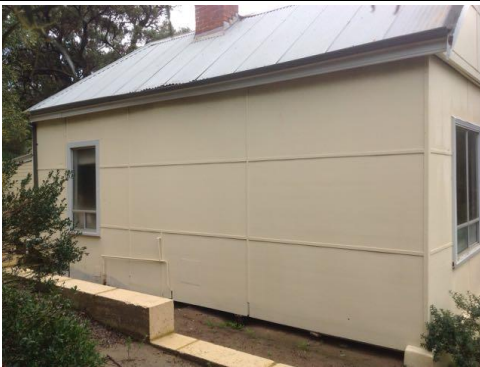
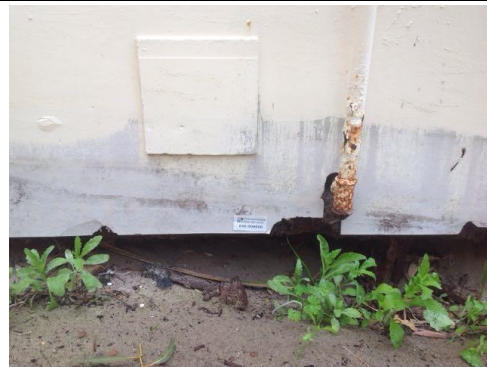
20732		Location		Description		Risk	
Internal/ External:	External		Material Description:	Cement Product	Condition:	Fair (Minor Damage)	
Level:	External Ground		Sample No.:	ESS 004626	Friability:	Non Friable	
Building:	Friends of Allen Park Cottage		Sample Status:	Asbestos Detected	Disturbance Potential:	Low	
Extent (approx.):	25 m ²	Current Label:	Labelled	Sample Ref:	BA3259/07	Risk Rating:	Low
Room/Area:	002 - Western Elevation - Wall Cladding				Action Rating:	A3

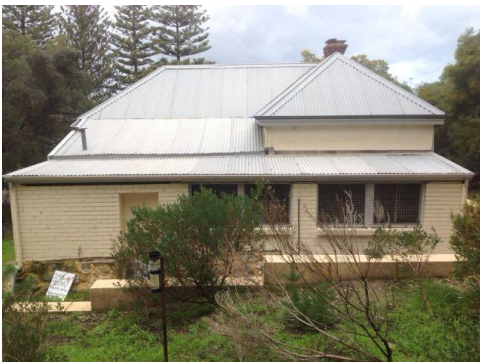
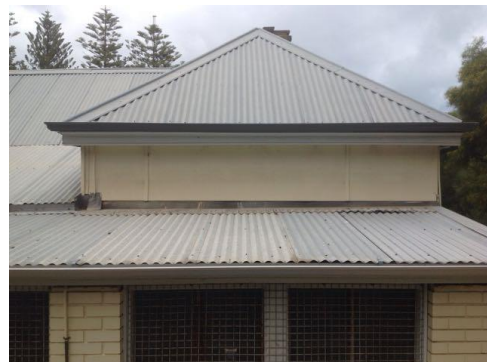
20718		Location		Description		Risk	
Internal/ External:	External		Material Description:	Cement Product	Condition:	Good (Undamaged)	
Level:	External Ground		Sample No.:	Assumed same as ESS 004626	Friability:	Non Friable	
Building:	Friends of Allen Park Cottage		Sample Status:	Asbestos Detected	Disturbance Potential:	Rare	
Extent (approx.):	4 m ²	Current Label:	Labelled	Sample Ref:	BA3259/07	Risk Rating:	Very Low
Room/Area:	003 - Northern Elevation - Wall Cladding				Action Rating:	A4

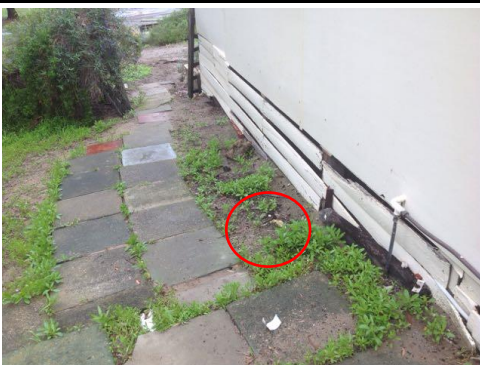
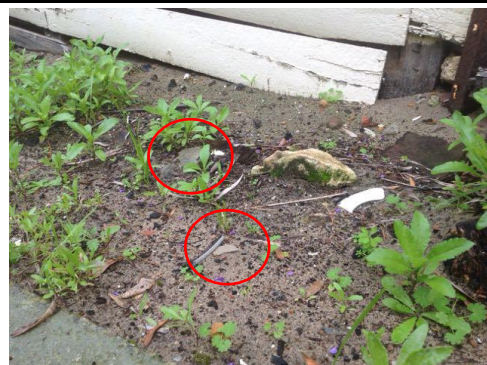
20729		Location		Description		Risk	
Internal/ External:	External		Material Description:	Cement Product	Condition:	Very Poor (High Amount of Damage)	
Level:	External Ground		Sample No.:	Assumed same as ESS 004626	Friability:	Non Friable	
Building:	Friends of Allen Park Cottage		Sample Status:	Asbestos Detected	Disturbance Potential:	Moderate	
Extent (approx.):	>3 no	Current Label:	Unlabelled	Sample Ref:	-	Risk Rating:	Low
Room/Area:	004 - Eastern Elevation - Debris				Action Rating:	A2

Environmentally clean/Emu pick area
All debris found was removed for analysis

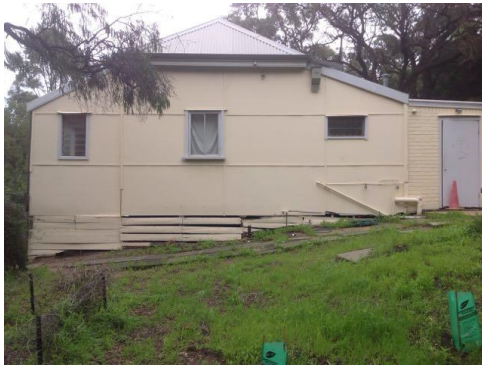
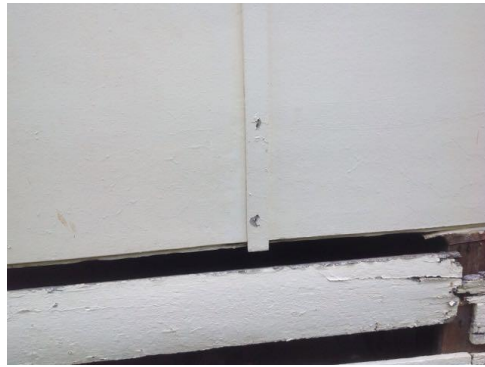
20733		Location		Description		Risk	
Internal/ External:	External		Material Description:	Cement Product	Condition:	Fair (Minor Damage)	
Level:	External Ground		Sample No.:	Not Sampled	Friability:	Non Friable	
Building:	Friends of Allen Park Cottage		Sample Status:	Assumed Asbestos	Disturbance Potential:	Low	
Extent (approx.):	20 lin m	Current Label:	Unlabelled	Sample Ref:	-	Risk Rating:	Low
Room/Area:	004 - Eastern Elevation - Joint strips				Action Rating:	A3

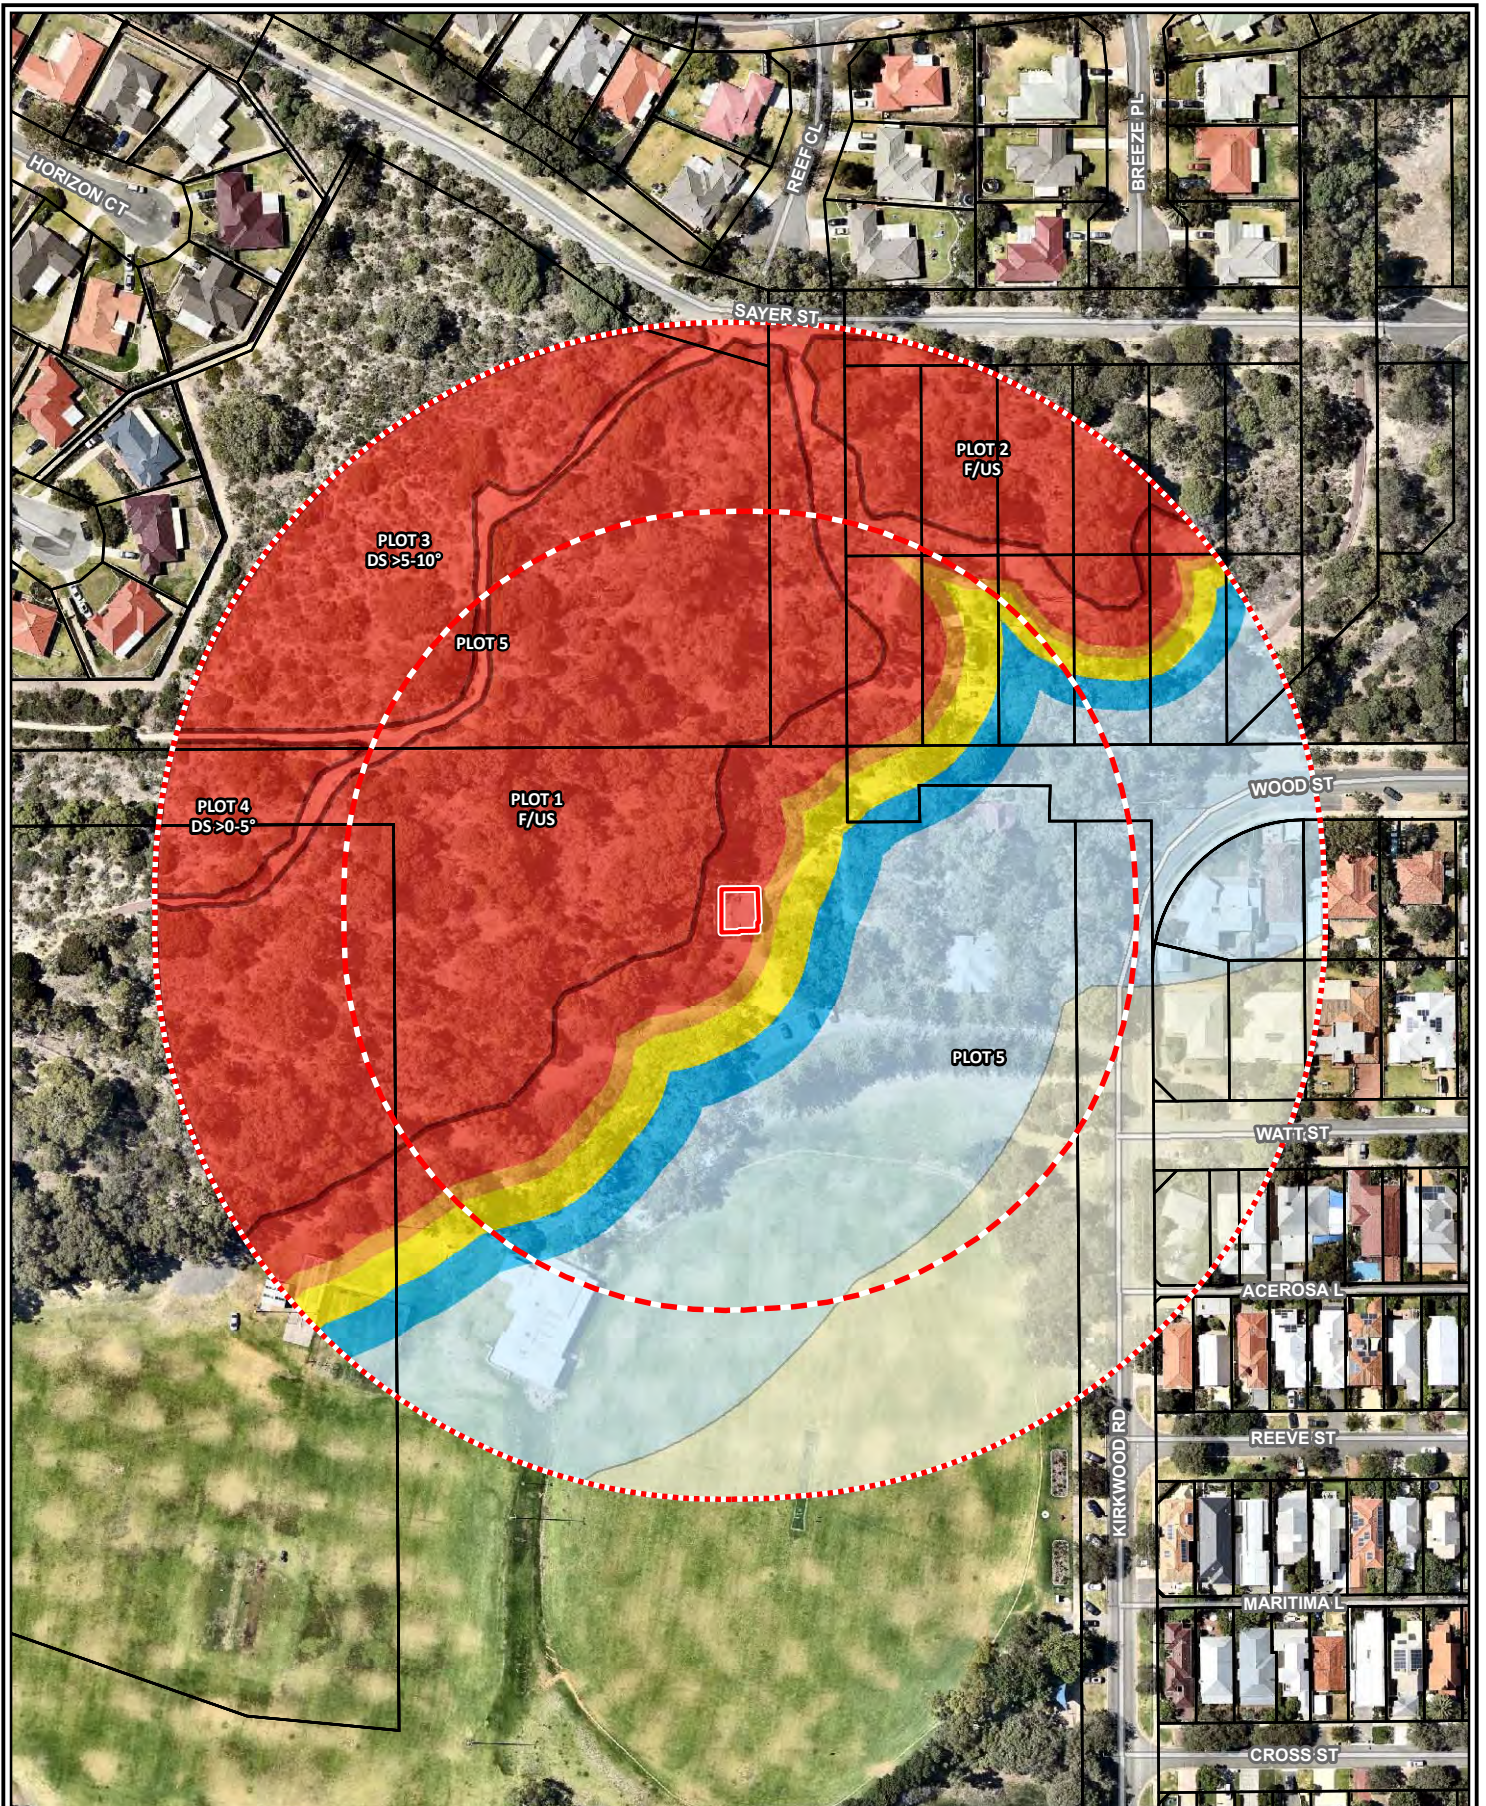
FIGURE 5

Results of the BAL contour assessment for the both the current site location and potential relocation area are detailed in Table 4 and Table 5 and illustrated in Figure 5 and Figure 6. The highest BAL applicable to the cottage in its current location is BAL-FZ and if relocated to the potential relocation area, BAL-29 will be achieved. Further amendment to the building location that increases the separation distance between the building and adjacent Class A forest vegetation will result in further reduction of the BAL rating.

Bushfire protection criteria	Method of compliance	Proposed bushfire management strategies
	Acceptable solutions	
Element 1: Location	A1.1 Development location	The BAL contour map (Figure 5) indicates that the current site is situated within BAL-FZ and is likely subject to significant radiant heat and ember attack. For compliance to be achieved for this acceptable solution, there is potential to reduce the radiant heat impacts on the subject site in its current location through the implementation of a 21 m wide Asset Protection Zone (APZ), as depicted in Figure 7 and Figure 8.
Element 2: Siting and design	A2.1 Asset Protection Zone	In order for the cottage to attain a compliant BAL-29 rating in its current location, a 21 m wide APZ around the site will need to be established and is to be landscaped and maintained in a low threat state as an APZ in accordance with Schedule 1 of the Guidelines (refer to Appendix A). The resulting increase in separation distance to the adjacent Class A forest and subsequent reduction in BAL impact is depicted in Figure 7 and Figure 8 respectively. If not implemented, the cottage will retain its BAL-FZ rating and is unlikely to be able to withstand the radiant heat and ember attack impacts associated with a bushfire.

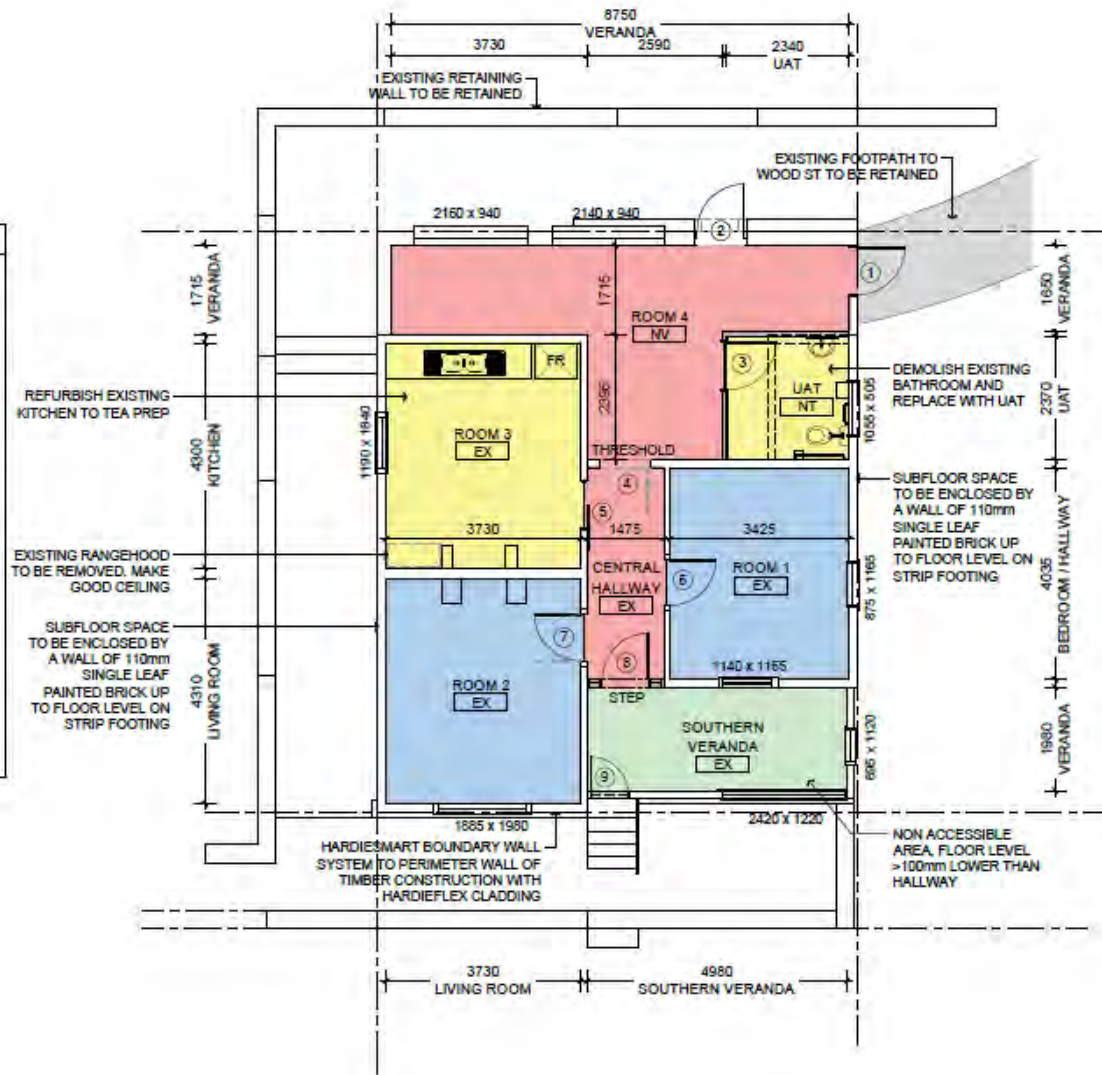
Proposed Alterations

DOOR LEGEND:	
1.	NEW DOOR WITH A SOLID CORE, SEALED SO AS TO PROVIDE NO GAPS GREATER THAN 3mm. 980 x 2160mm. ENSURE DOOR HARDWARE IS COMPLIANT WITH AS1428.1. ENSURE PAVING LEVEL AT THRESHOLD

2.	EXISTING SLIDING DOOR TO BE REPLACED WITH SOLID CORE SWING DOOR 920mm CLEAR, SEALED SO AS TO PROVIDE NO GAP GREATER THAN 3mm. WIDEN DOOR FRAME TO FIT NEW DOOR. BRICK CAPPING TO OLD RETAINING WALL IN DOORWAY TO BE REMOVED AND ENDS OF WALL MADE GOOD

5.	EXISTING DOOR FRAME REPLACED WITH SLIDING DOOR 850 x 2100mm, TO COMPLY WITH FOOD STANDARD REQUIREMENTS FOR ENTRY TO TEA ROOM
6.	EXISTING DOOR TO BE RETAINED 880 x 2100mm, HARDWARE TO BE REPLACED WITH ALTERNATIVES COMPLIANT WITH AS1428.1

7.	EXISTING NON-COMPLIANT DOOR TO BE RE-HUNG 880 x 2100mm, HARDWARE TO BE REPLACED WITH ALTERNATIVES COMPLIANT WITH AS1428.1
8.	EXISTING NON-ACCESSIBLE DOOR TO BE RETAINED, 880 x 2100

WINDOW NOTE:	
REPLACE ALL EXTERNAL WINDOWS WITH NEW ALUMINIUM FRAMES, TOUGHENED LOW-E GLASS
