Technical Services Reports

Committee Consideration – 11 September 2012

TS18.12	Request for Retrospective Approval of Nature Strip Development at 47 Esplanade, Nedlands
----------------	---

TS19.12	Requests for Street Tree Removals Referred for Council Consideration
----------------	---

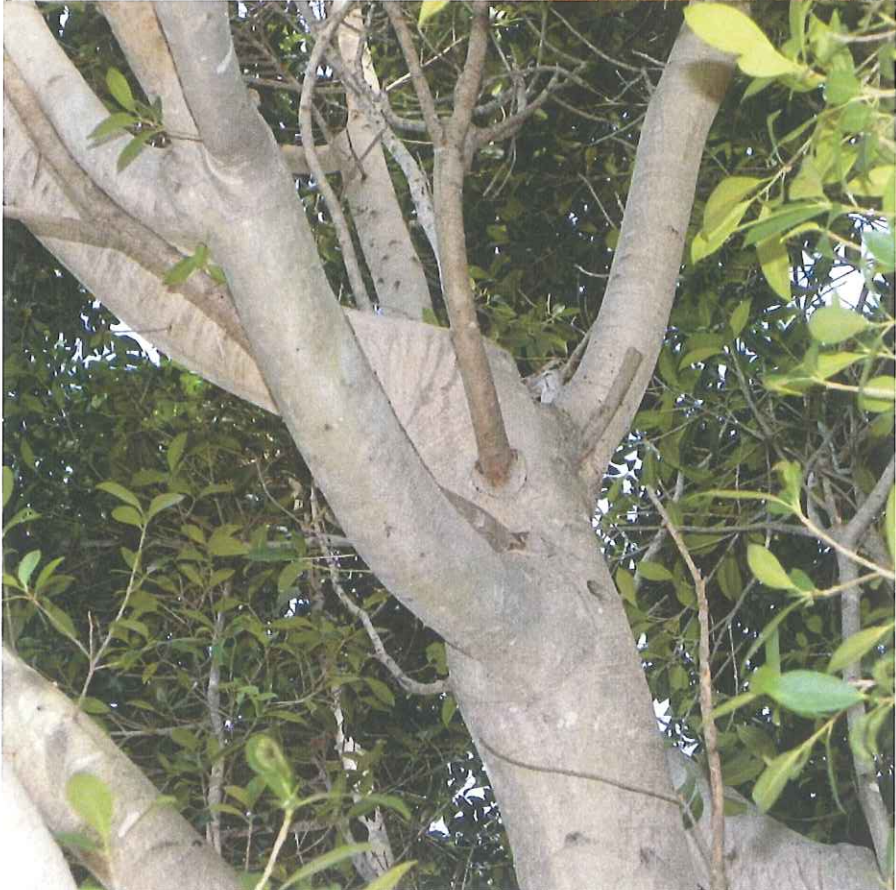
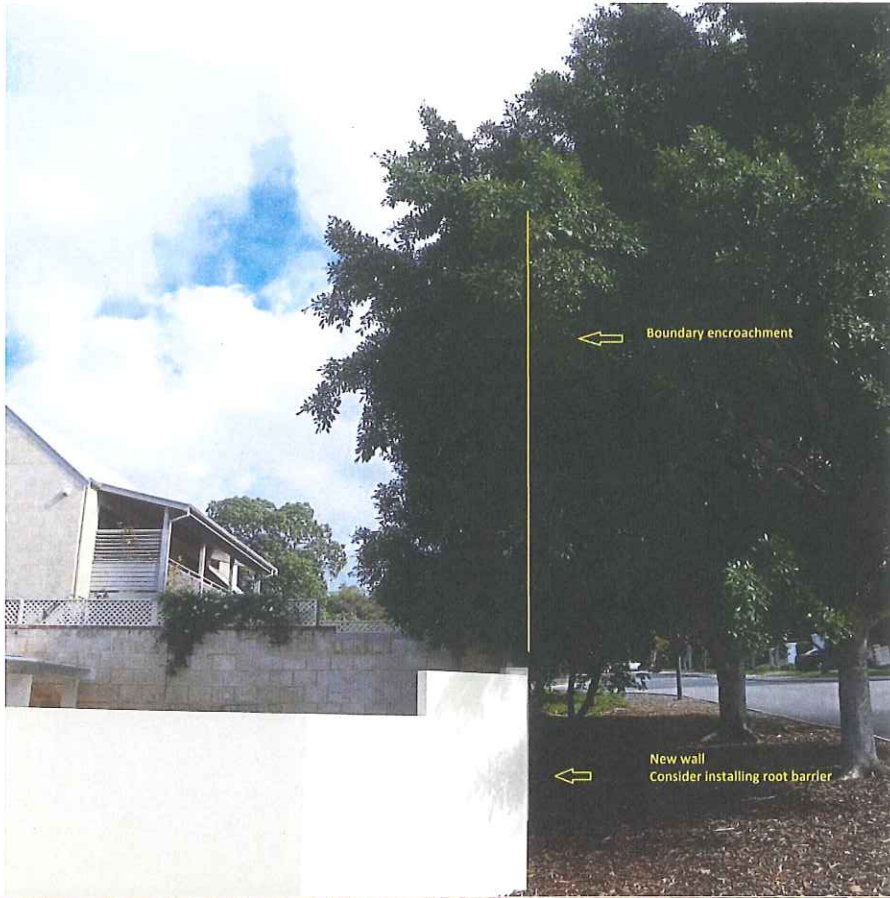
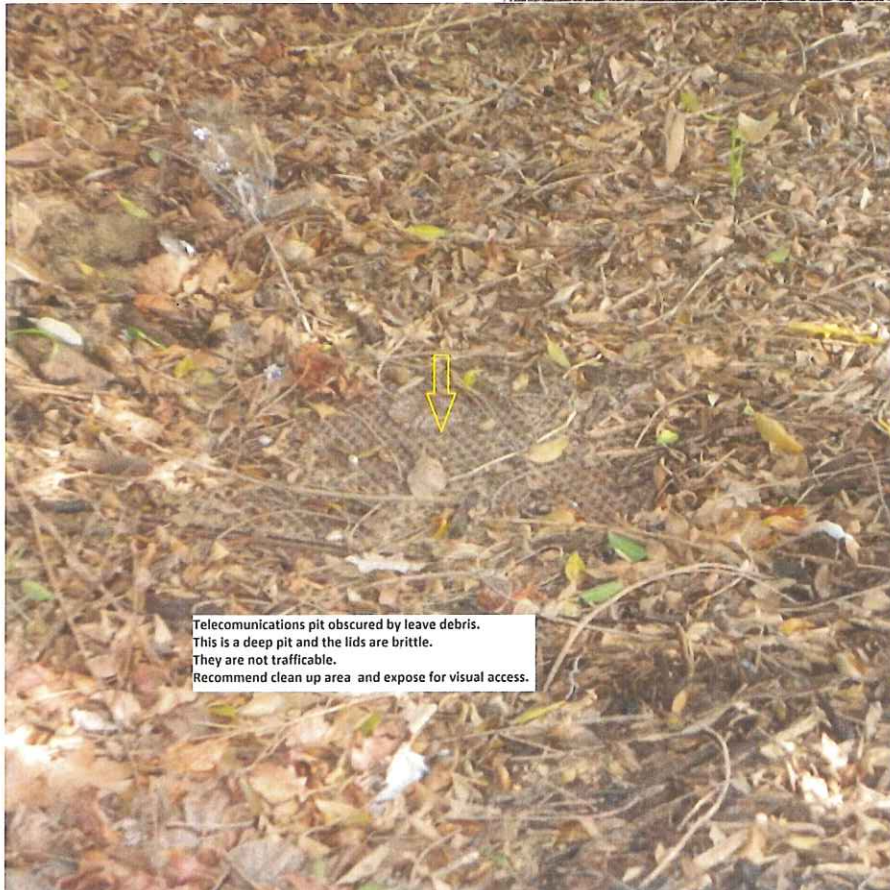
Close up view of epicormic structures
